## SEAWALL CONDITION ASSESSMENT

LESLEY MANAGEMENT HARBORSIDE CONDOMINIUM  
24 Lee Street  
Marblehead, Massachusetts

February 2017

File No. 18.0172708.00

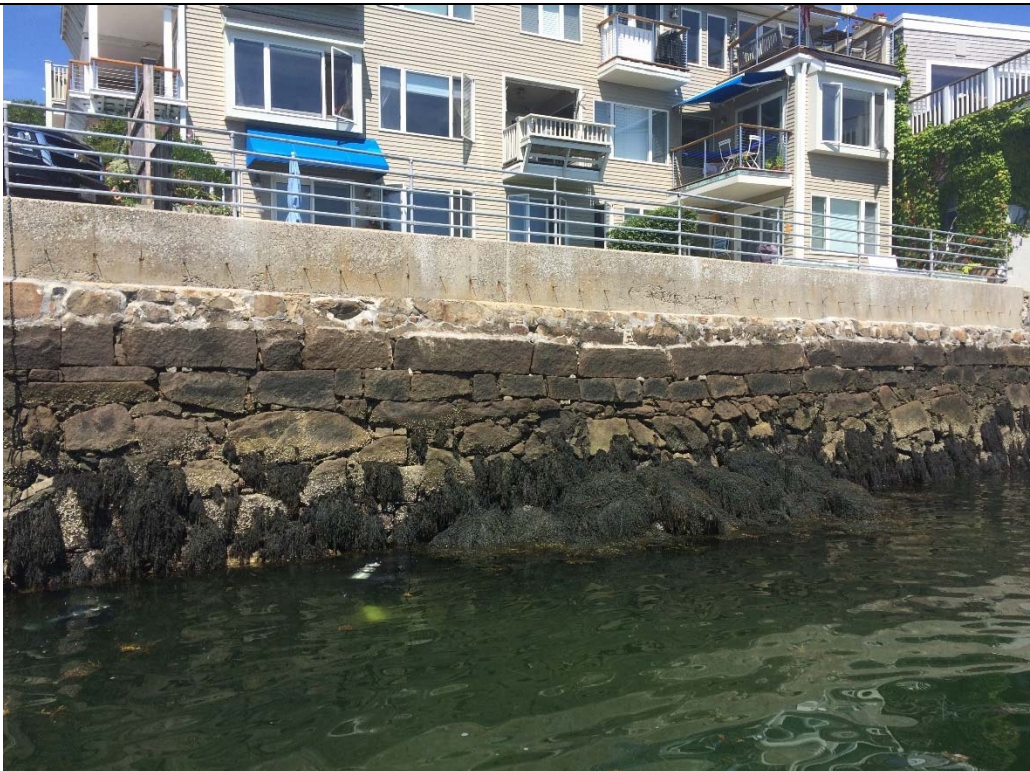
The overall condition of the existing seawall Type 1 was observed to range from **Fair** to **Satisfactory**, with two locations with observed **Poor** condition. The Type 1 seawall extends approximately 65 linear feet south from the northern property line (See **Photograph 2**). The seawall consists of irregularly shaped stone extending from the mudline to approximately MHW. Two courses of cut granite block were observed above the irregular stone; the lower course of a smaller size than the upper course. Above that was an approximate two-foot thick layer of stone and mortar with an approximate three-foot high concrete cap. A steel railing is mounted to the top of the cap. No weep holes were observed along this portion of the seawall, although gaps exist between stones. Approximately 15 feet of the seawall is fronted by a mound of placed stone at an apparent bow in the seawall (See **Photograph 2**). Smaller stone located at the base of the seawall appeared to follow the natural slope of the mudline.

| <b>Description:</b><br>Existing (wall type 1) at northern end of property. Note prior settlement in upper stone layers and added stone fronting the wall. | | |

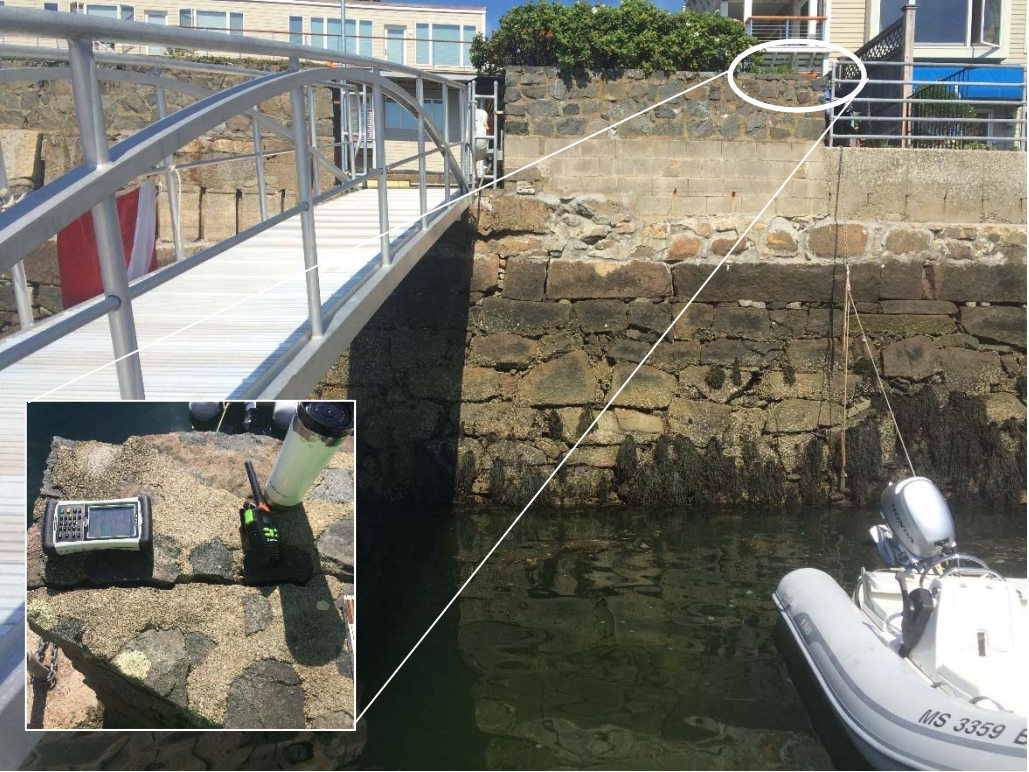
The overall condition of the existing seawall Type 2 was observed to be **Satisfactory**, with an isolated section of the upper planter in **Poor** condition. The Type 2 seawall extends from the end of the Type 1 seawall construction for approximately 12 linear feet. The seawall is constructed similarly to Type 1 with the lower portion of the seawall composed of granite stones, two courses of cut granite block and then a layer of stone and mortar. Above this layer, the seawall consists of an approximate three-foot-high portion of concrete blocks and then an approximate three-foot-high mortared stone planter (See **Photograph 3**). A large rosa rugosa plant and irrigation system are located within this planter. Stone located at the base of the seawall appeared to follow the natural slope of the mudline. No weep holes were observed along this portion of the seawall, although gaps exist between stones. In general, the lower portion of the seawall was observed to have gaps between the various stones and had been partially filled with chinking stones. Heavy marine growth was located along the face of the seawall from the mudline to a few feet below MHW. An approximate ¾-inch to 1-inch crack was observed through the top of the stone planter at the northern end of the planter (See **Photograph 3** inset).

| <b>Description:</b><br>Existing seawall (wall types 1, 2, 3 and 4 from right to left) at northern gangway. Note crack in top of planter. | | | |

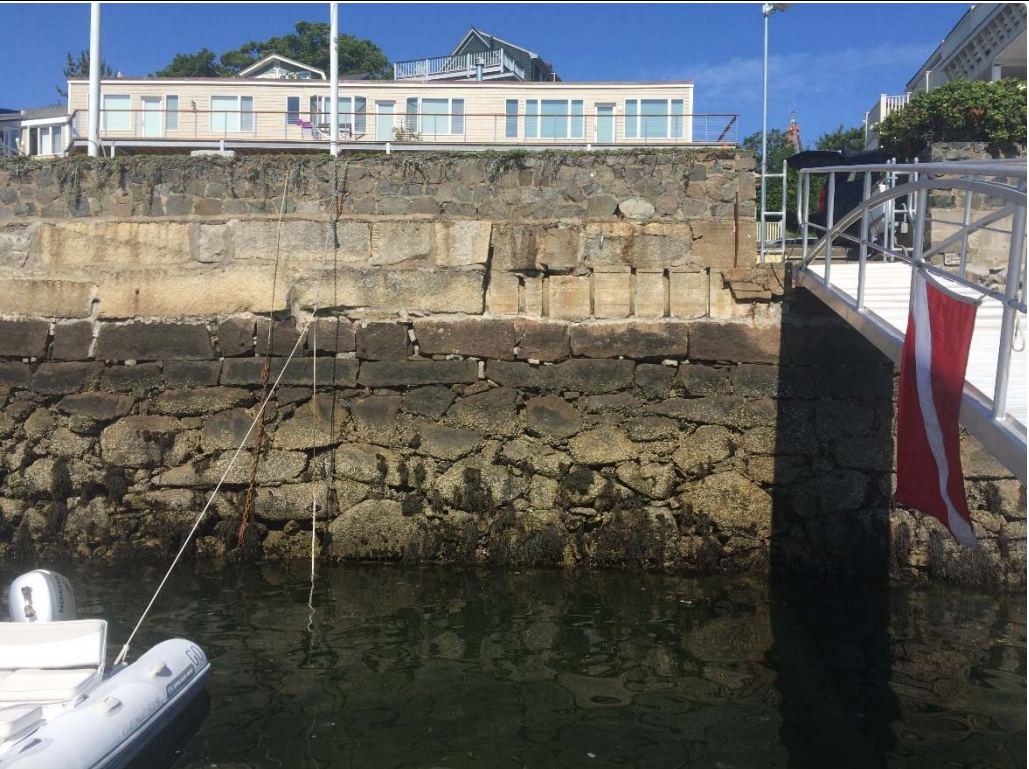
| <b>Description:</b><br>Existing seawall (wall types 3 and 4 from right to left) seaward of parking lot. | | |

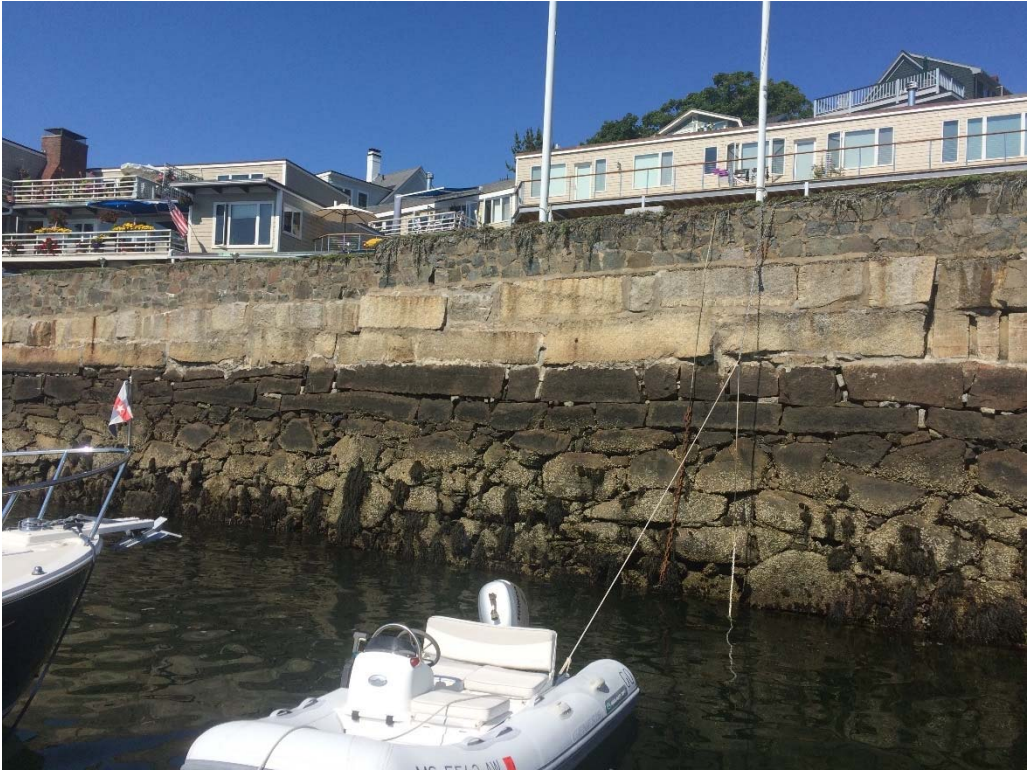
| <b>Description:</b><br>Existing seawall (wall type 4) seaward of parking lot. | | | |

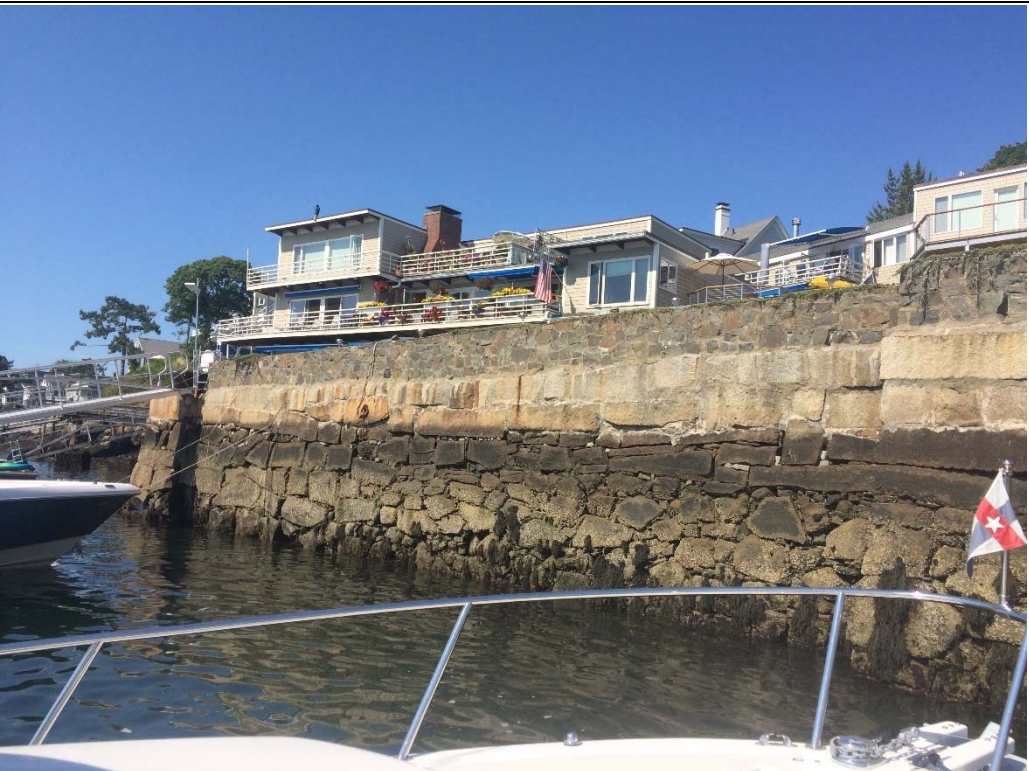
| <b>Description:</b><br>Existing seawall (wall types 4 and 5 from right to left) seaward of parking lot. | | |

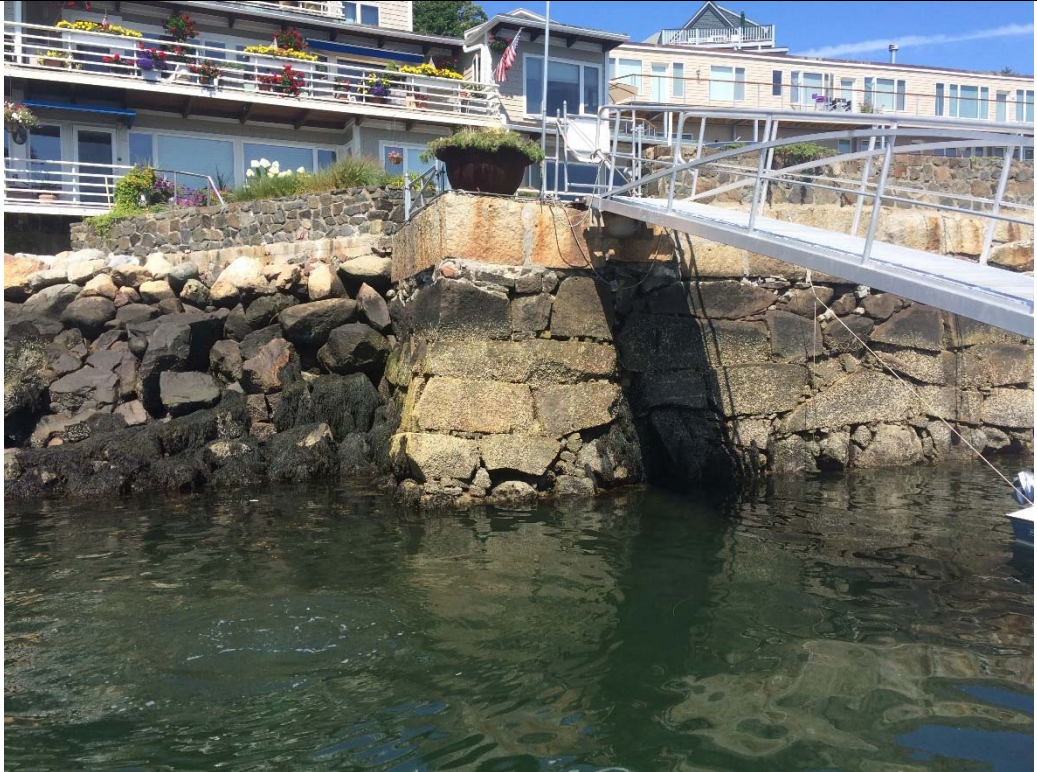
The overall condition of the existing seawall Type 6 was observed to be **Fair to Poor**. The seawall in the location consists of an observed concrete seawall of unknown depth that appears to have been poured directly on the stones of the existing rip rap slope or possibly on ledge (See **Photographs 7 and 10**). A mortared stone planter is

| <b>Description:</b><br>Existing seawall and<br>revetment (wall types 5<br>and 6 from right to left)<br>at corner. | | | |

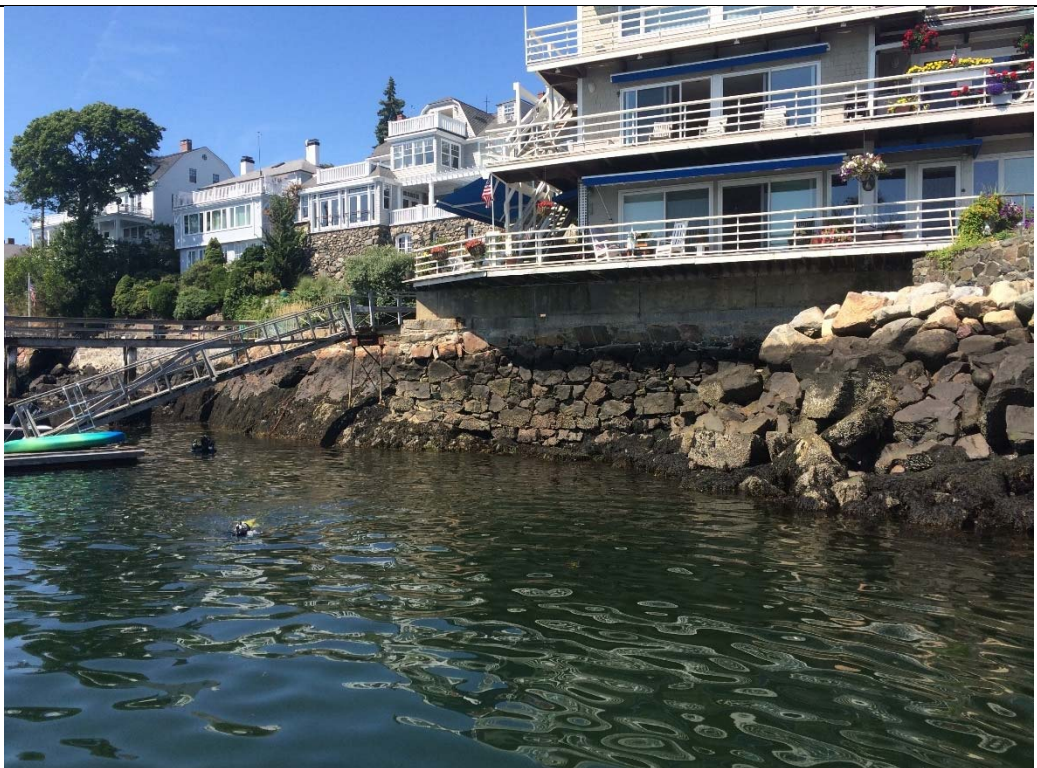
| <b>Description:</b><br>Existing stone riprap and seawall (wall types 6 and 7 from right to left). | | |

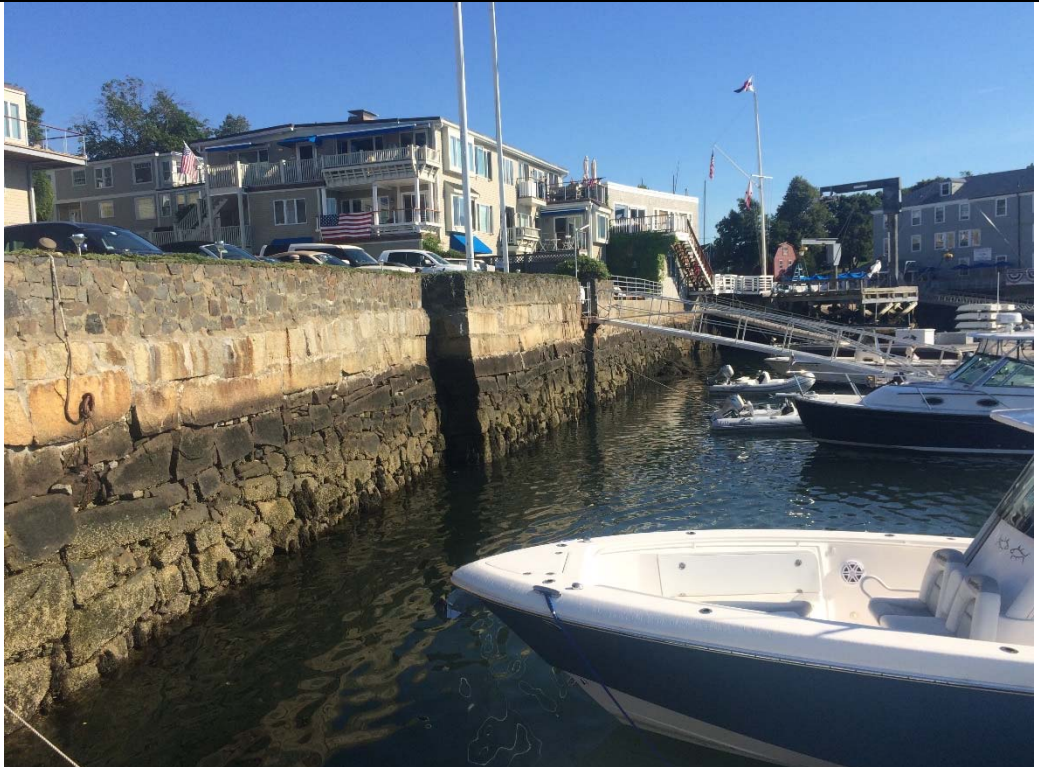
| <b>Description:</b><br>Existing seawall (wall type 4) seaward of parking lot. | | | |

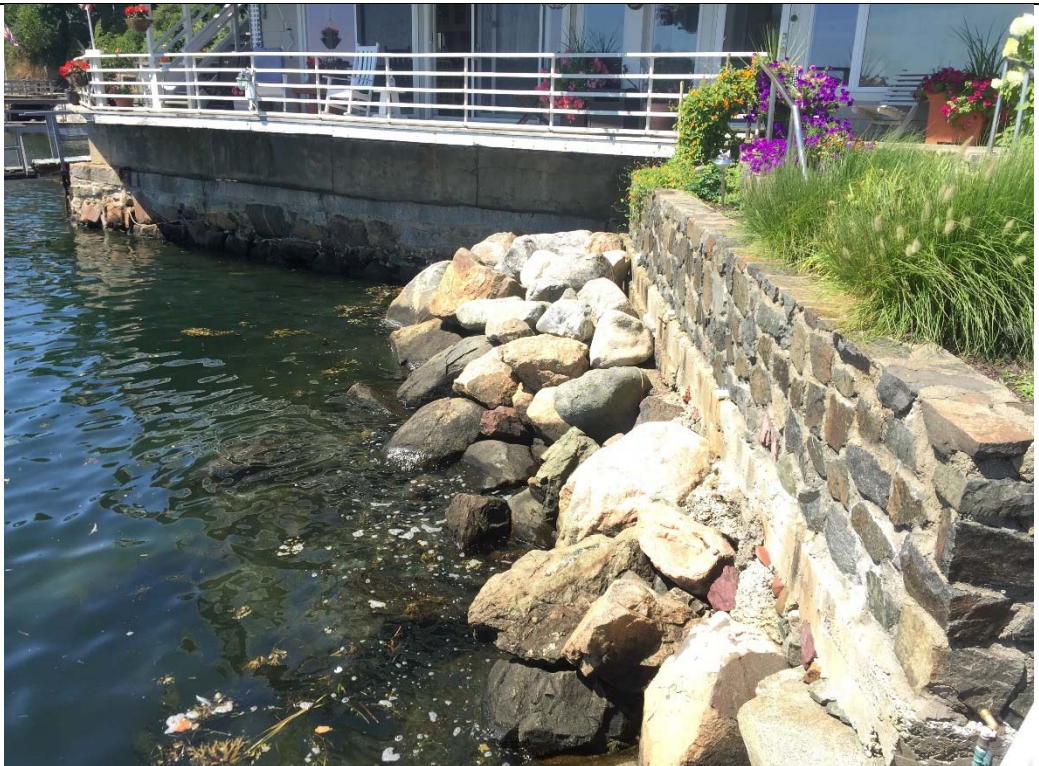
| <b>Description:</b><br>Existing stone and concrete with large stone riprap (wall types 6 and 7 from right to left). | | |

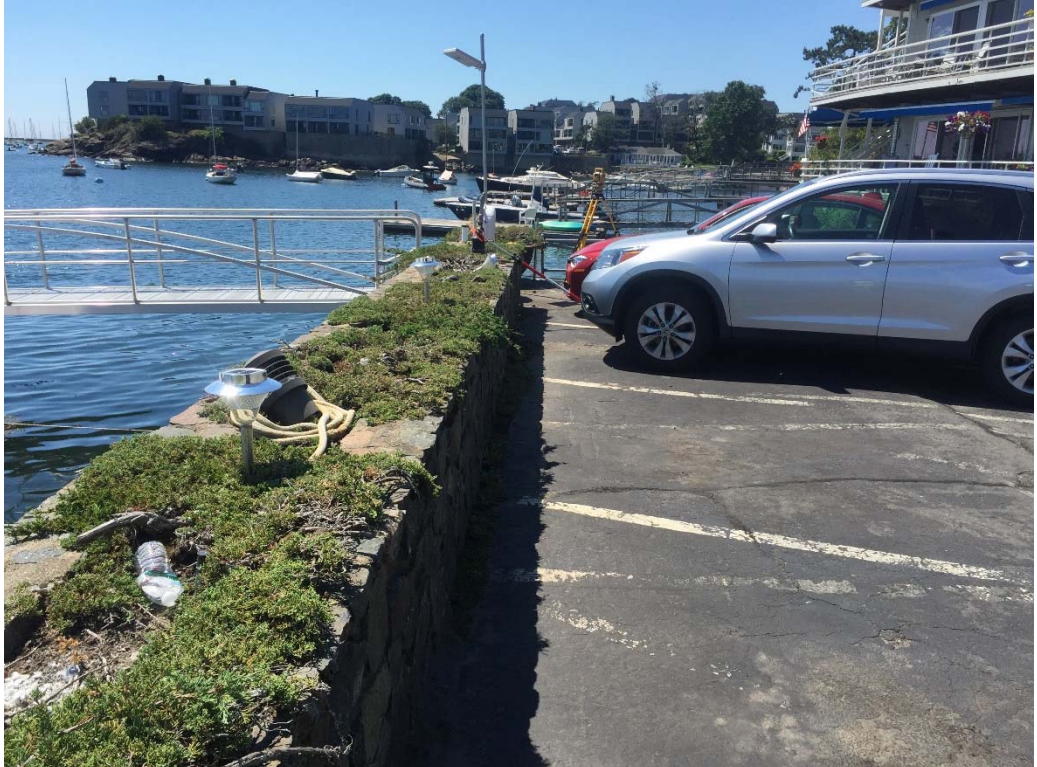
| <b>Description:</b><br>Existing seawall planter with landscaping and parking lot (wall type 4). | | | |

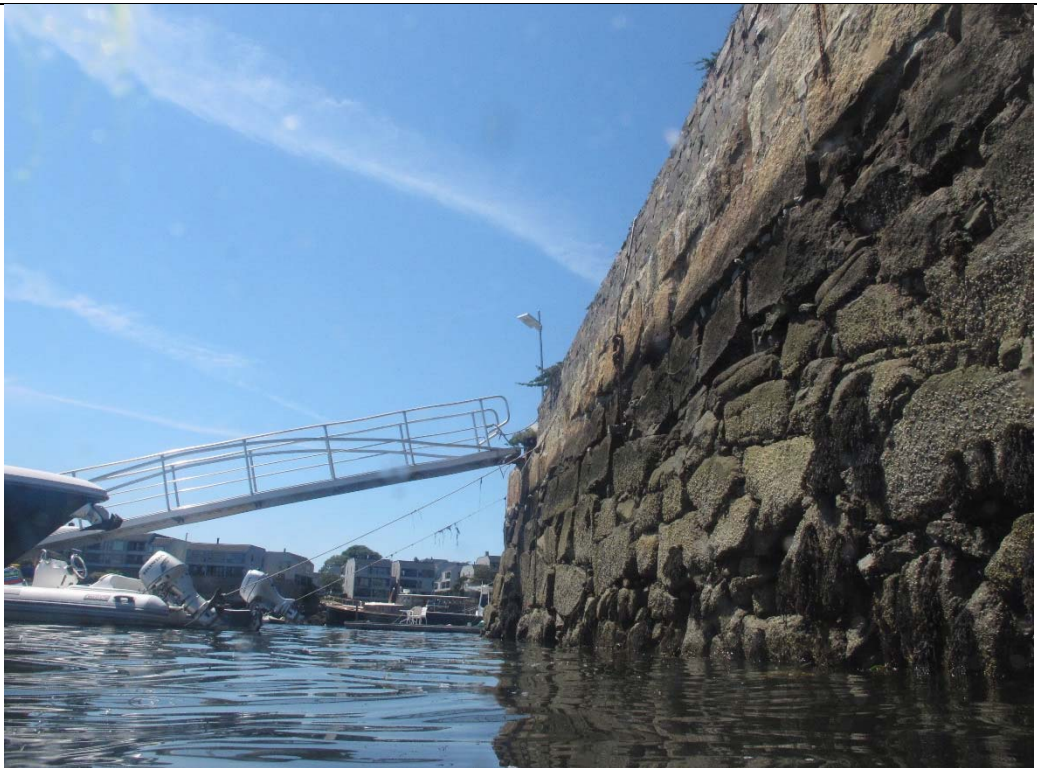
| <b>Description:</b><br>View of granite and stone wall face from water. | | |

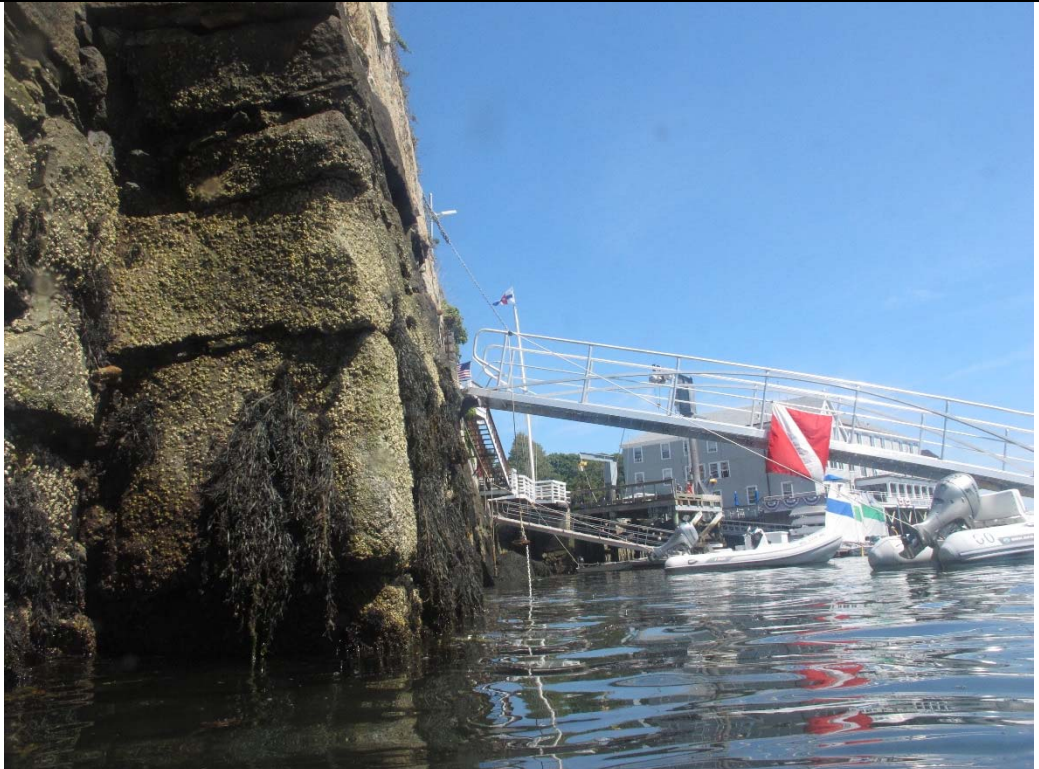
| <b>Description:</b><br>View of granite and stone wall face at bump out. | | | |

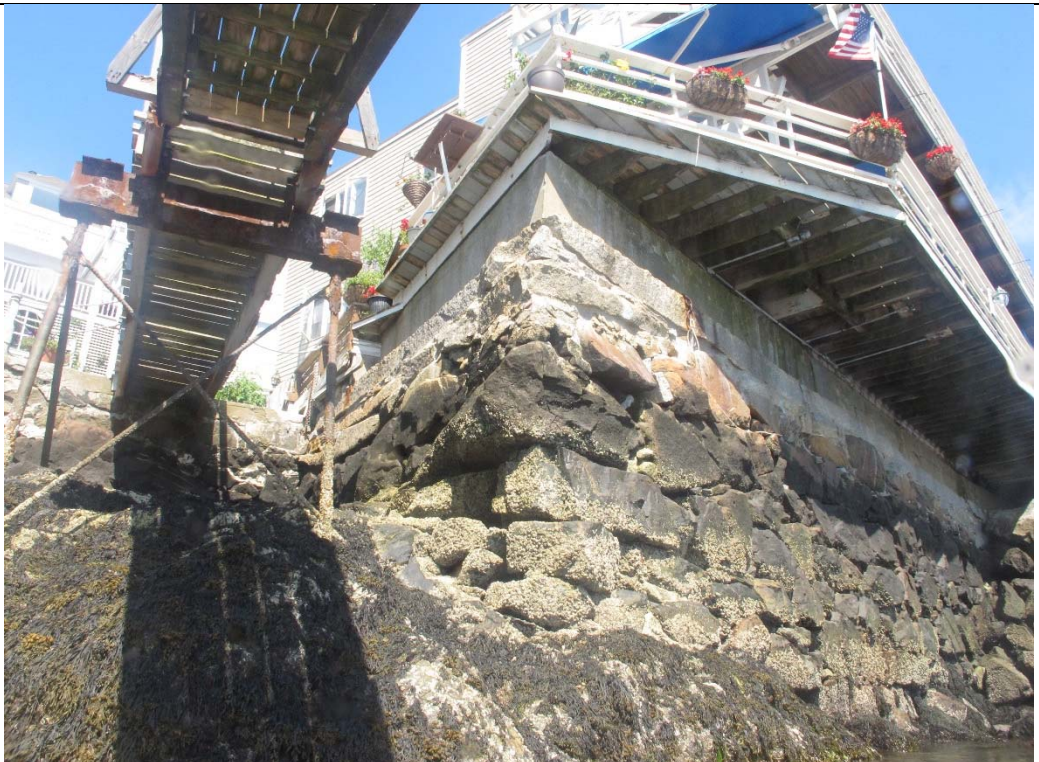
| <b>Description:</b><br>View of underside of condominium deck and concrete foundation/wall beneath. | | |

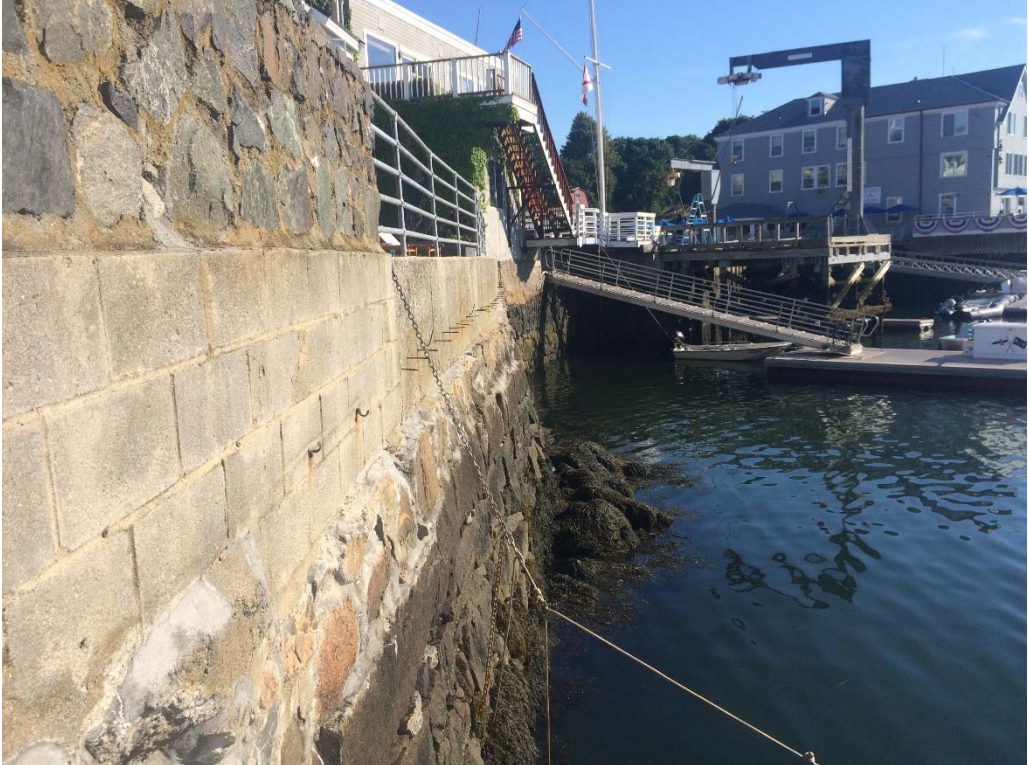
| <b>Description:</b><br>Apparent northern float connection into concrete section of existing wall. | | | |

- iv. Remove float anchorage from face of seawall. The north and south gangways are connected to the float and the seawall with 5<sup>th</sup> wheel connections. To reduce loading on the seawall, the 5<sup>th</sup> wheel float connection could be replaced with a roller system on the float end of the gangway. This would reduce additional loading to the seawall from movement of the floats. The existing anchorage system should be analyzed prior to this repair to assess the need for additional bottom-anchors.

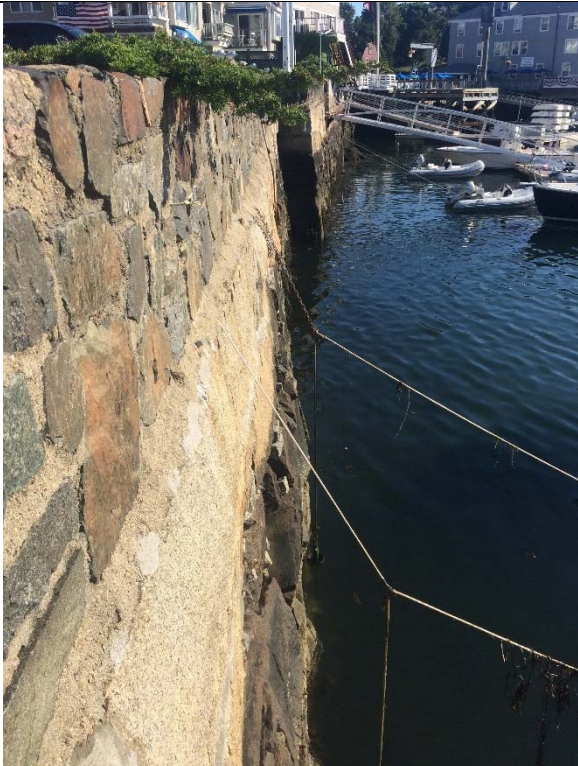
| <b>Description:</b><br>Apparent southern float connection into mortared section of existing wall. | | |

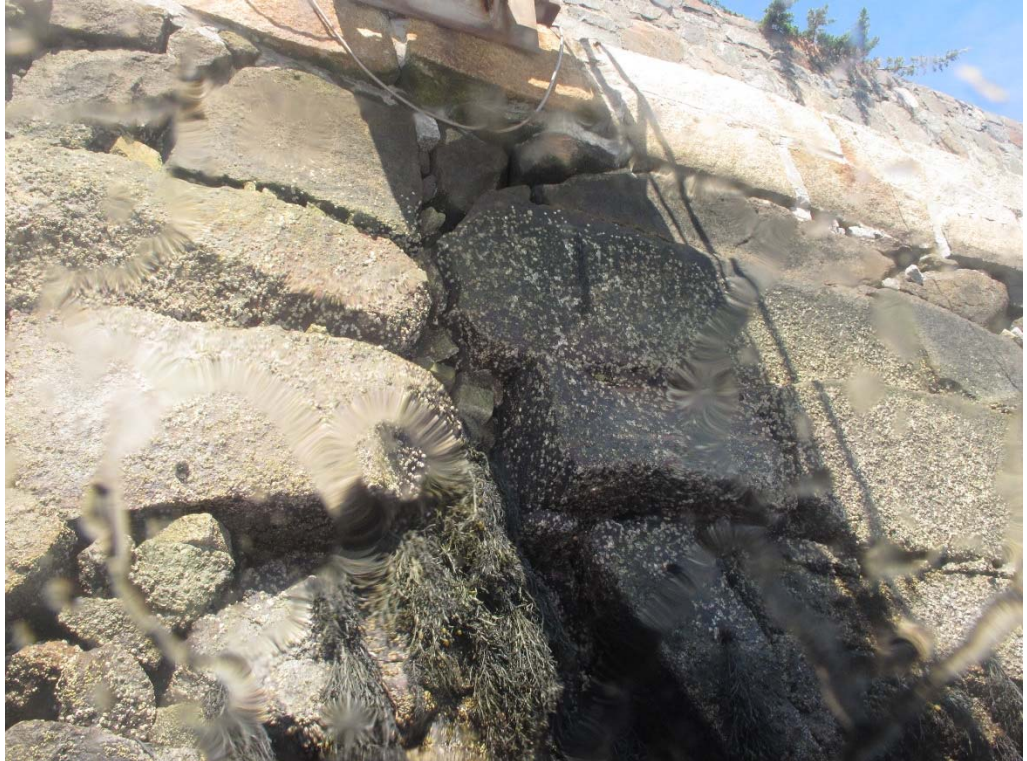
| <b>Description:</b><br>Area below southern gangway connection.<br>Note aligned vertical joints in adjacent courses of stone and void at bottom. | | | |

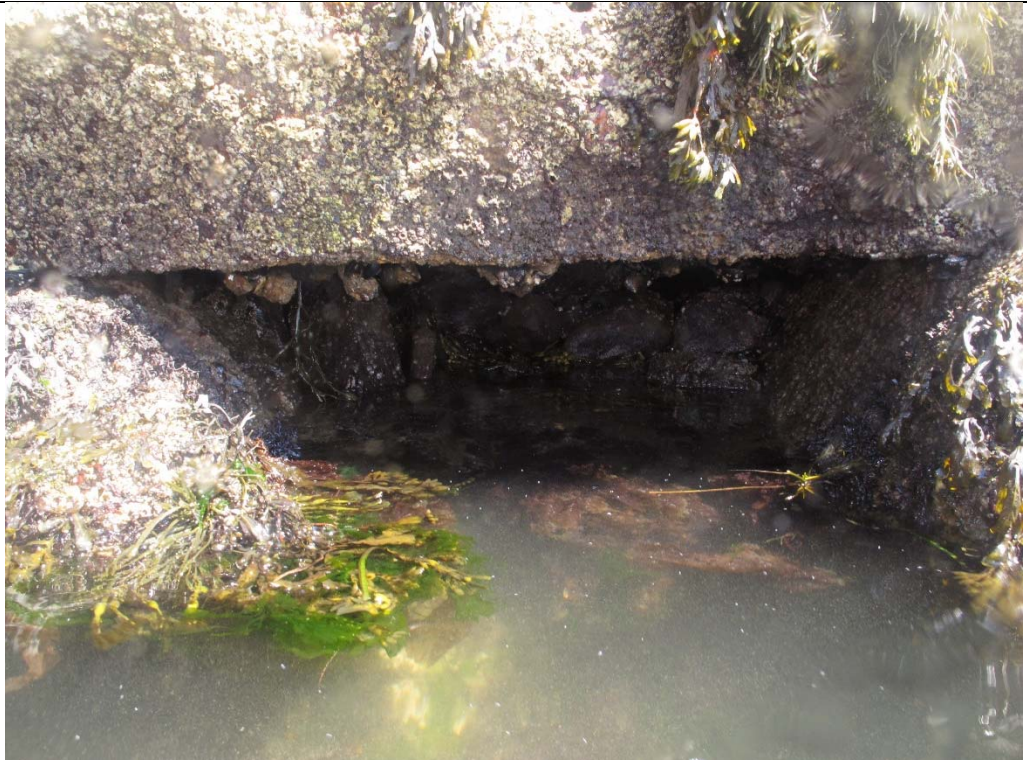
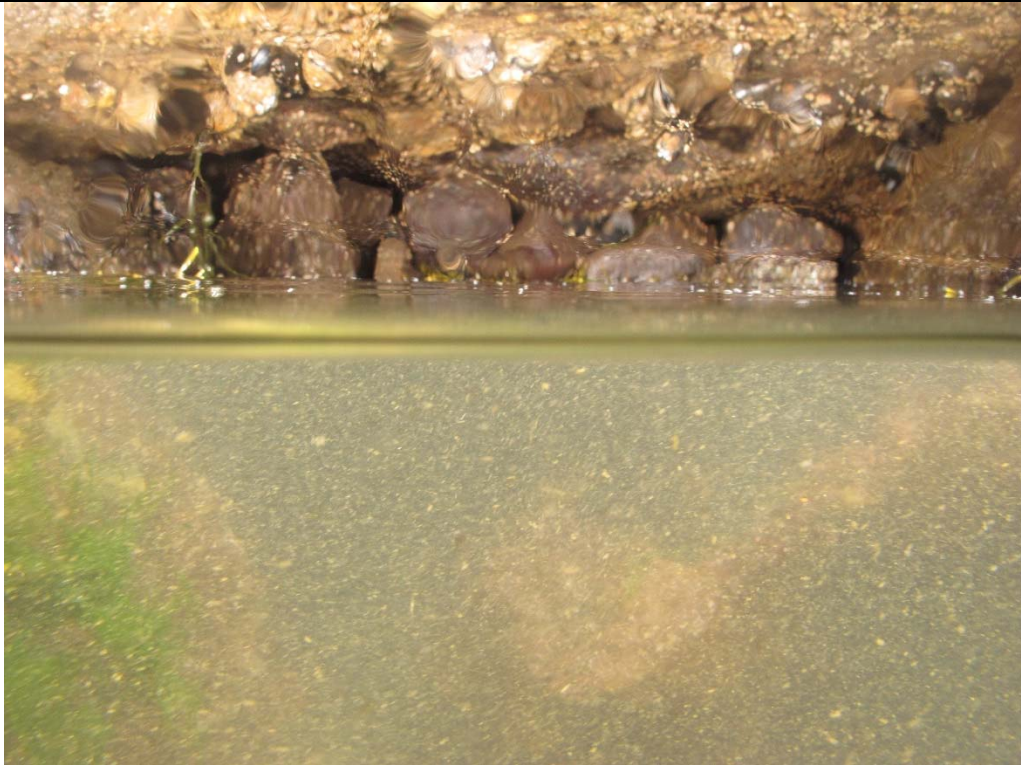
| <b>Description:</b><br>Void near bottom of wall<br>below southern gangway<br>connection. | | |

| <b>Description:</b><br>Void near bottom of wall below southern gangway connection. (Same void as Photograph 18, different angle). | | | |

- i. Chinking of joints and voids along face of seawall. Portions of the seawall, especially locations where voids were observed could be filled with additional stone and chinking stone. This would be performed during periods of low tide by hand and would likely have minimal impact to day-to-day activities at the site. Chinking of the seawall voids will still allow for potential drainage from behind the seawall. Underwater voids could be repaired with additional stone and chinking stone

or grout-filled bags installed by divers. The seawall chinking and void repair work will help to stabilize stones and reduce possible settlement and additional movement of stones.

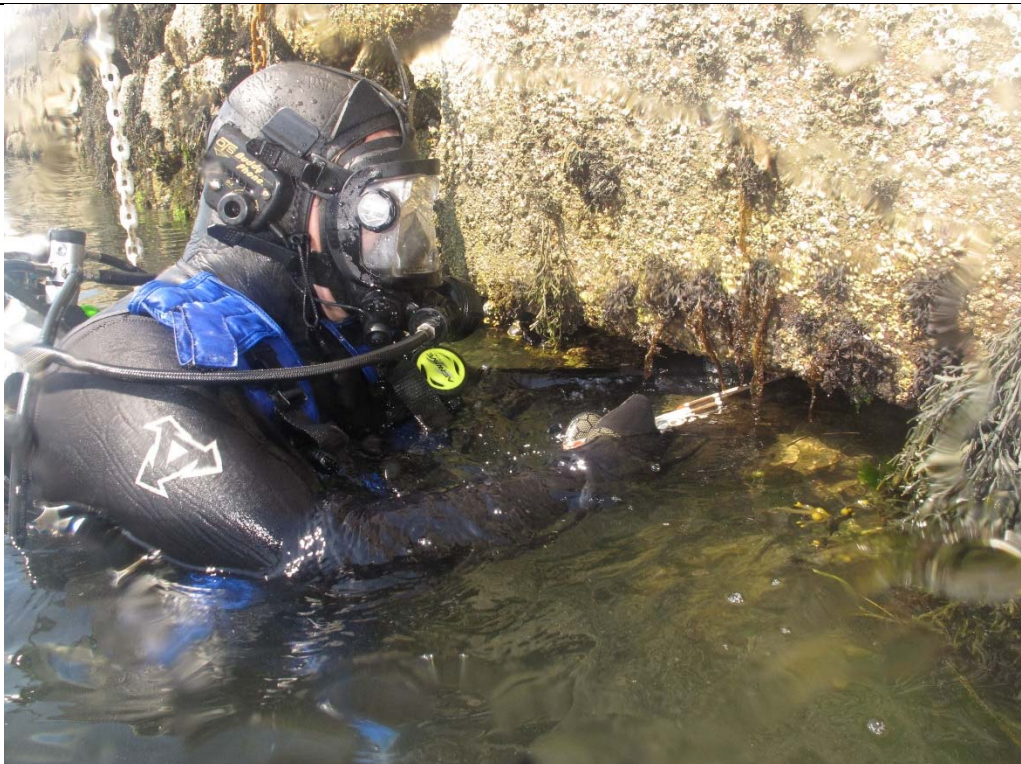
| <b>Description:</b><br>Void between courses near MLW approximately 10 feet south of the northern gangway. | | |

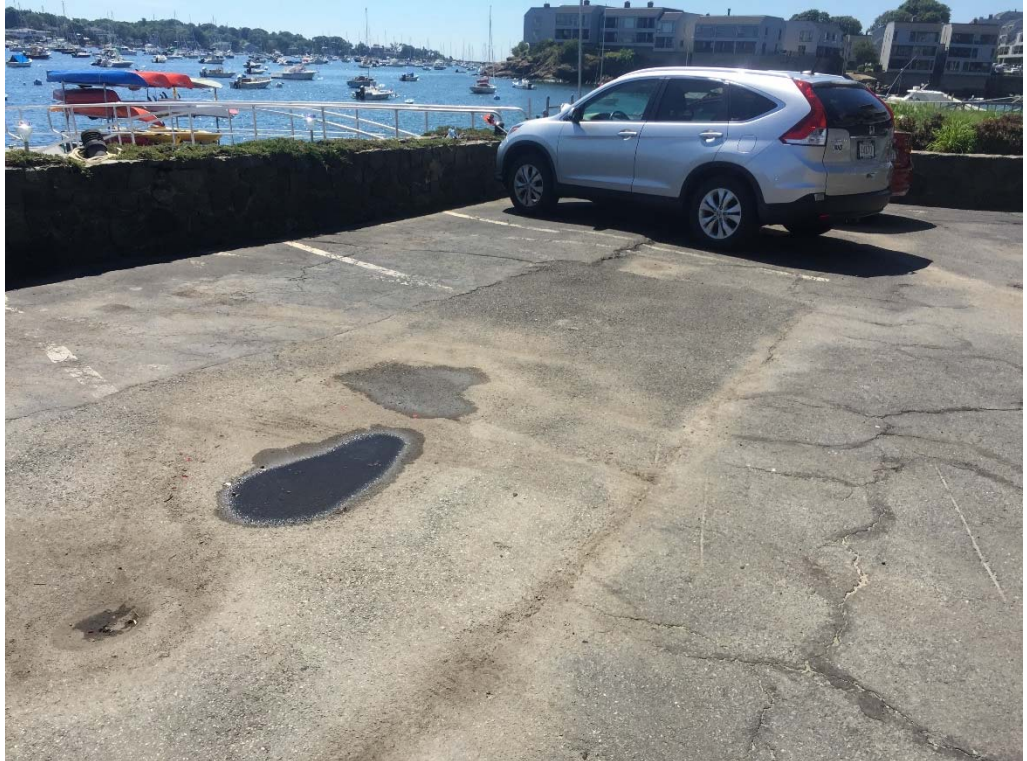
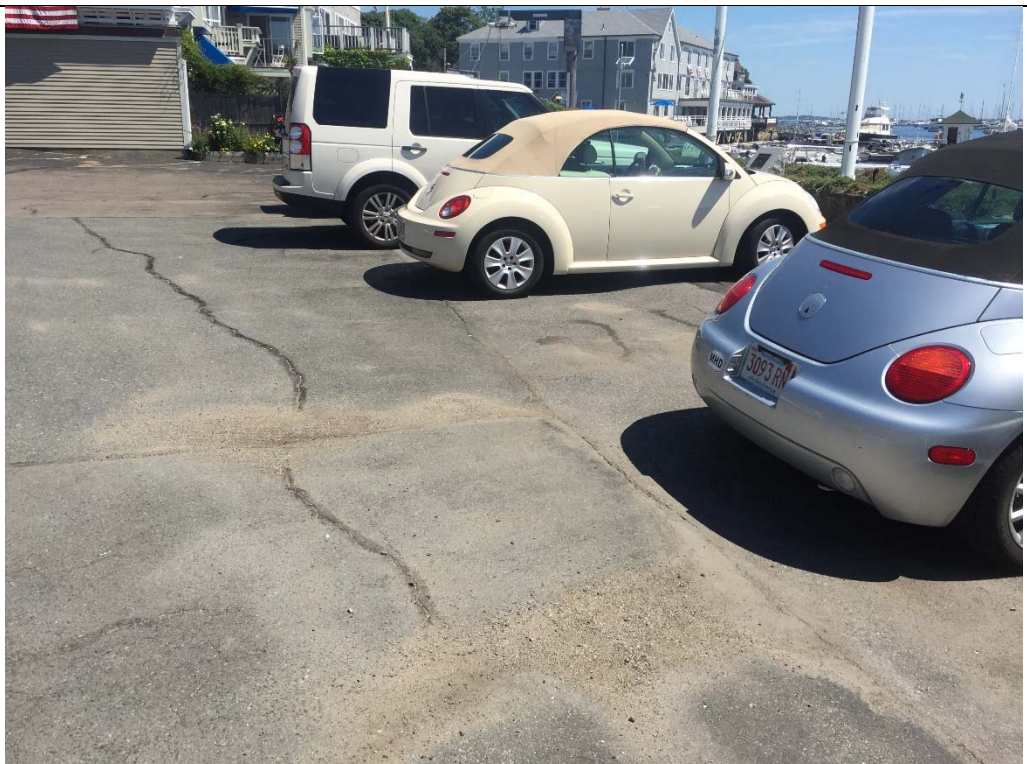
| <b>Description:</b><br>Depressions, sinkholes<br>and cracking of pavement<br>in parking area. | | | |

| <b>Description:</b><br>Depressions, sinkholes<br>and cracking of pavement<br>in parking area. | | |

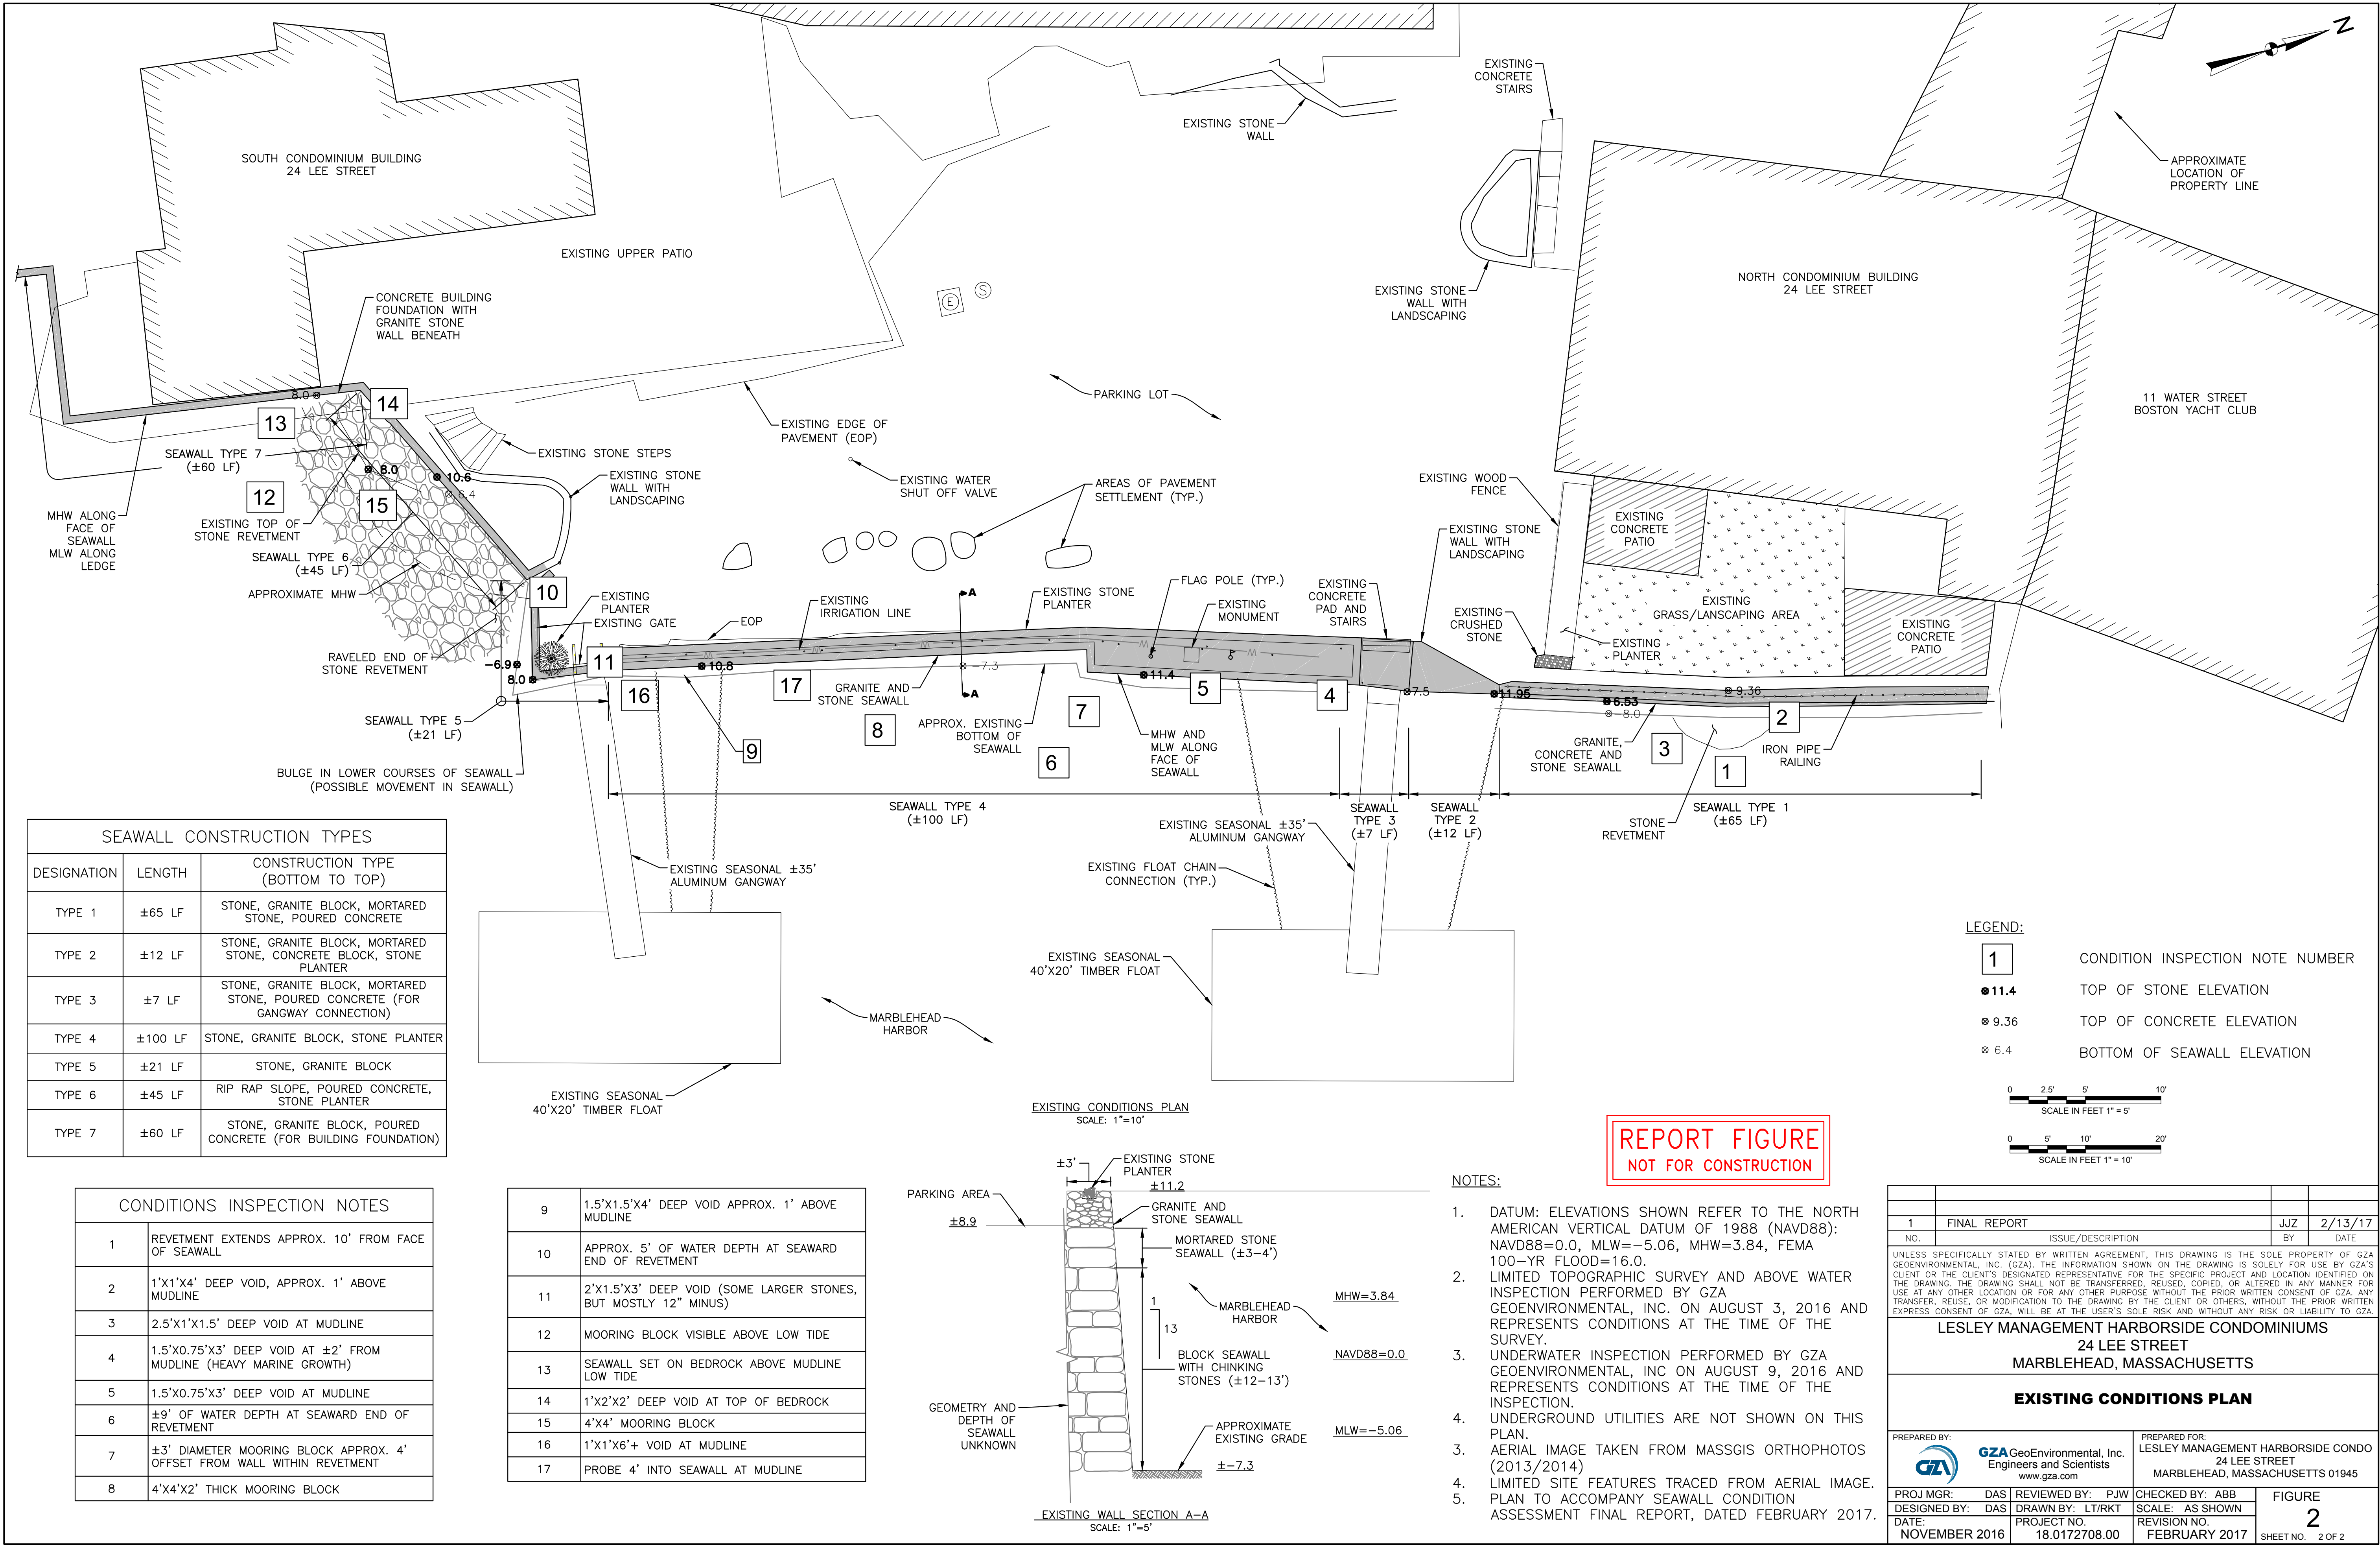
The drawing in **Appendix C** shows the existing site and observed seawall conditions by an assigned observation number. Notes are included within the table on the site plan.
