## **SITE DRAINAGE IMPROVEMENT REPORT**

**LESLEY MANAGEMENT HARBORSIDE CONDOMINIUM**  
24 Lee Street  
Marblehead, Massachusetts

November 2018  
File No. 18.0173596.00

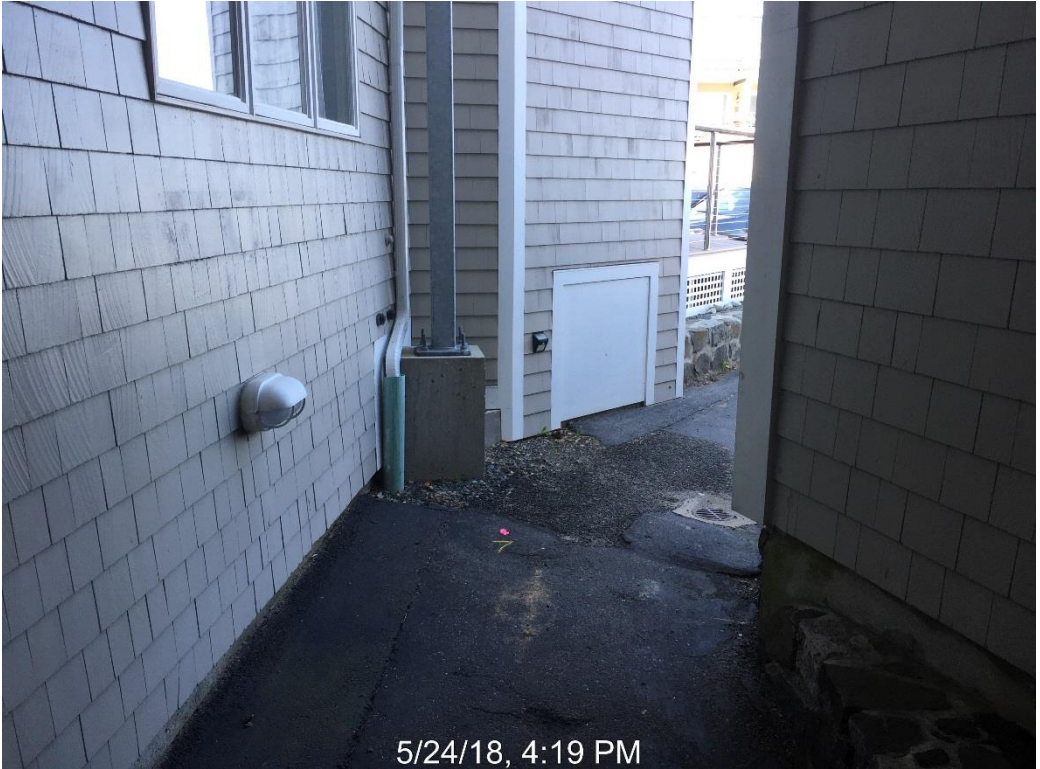
Storm water runoff from the roof area of Building B is collected by gutters at the eaves along the northern, eastern and western sides of the building, and are directed to seven downspouts located along the perimeter of the building. The downspouts near the northwestern corner and eastern midpoint of the building discharge into roof drain pipes near the building foundation. One downspout on the eastern side of the building discharges directly into the raised landscape bed adjacent to the building. The remaining four downspouts discharge to existing grades adjacent to the building foundation. A small field inlet to collect surface runoff is located in the paved walkway between Buildings B and D, see **Photograph 9**.

| <b>Description:</b><br>View of passageway between Buildings B and D from inside the passageway. | | | |

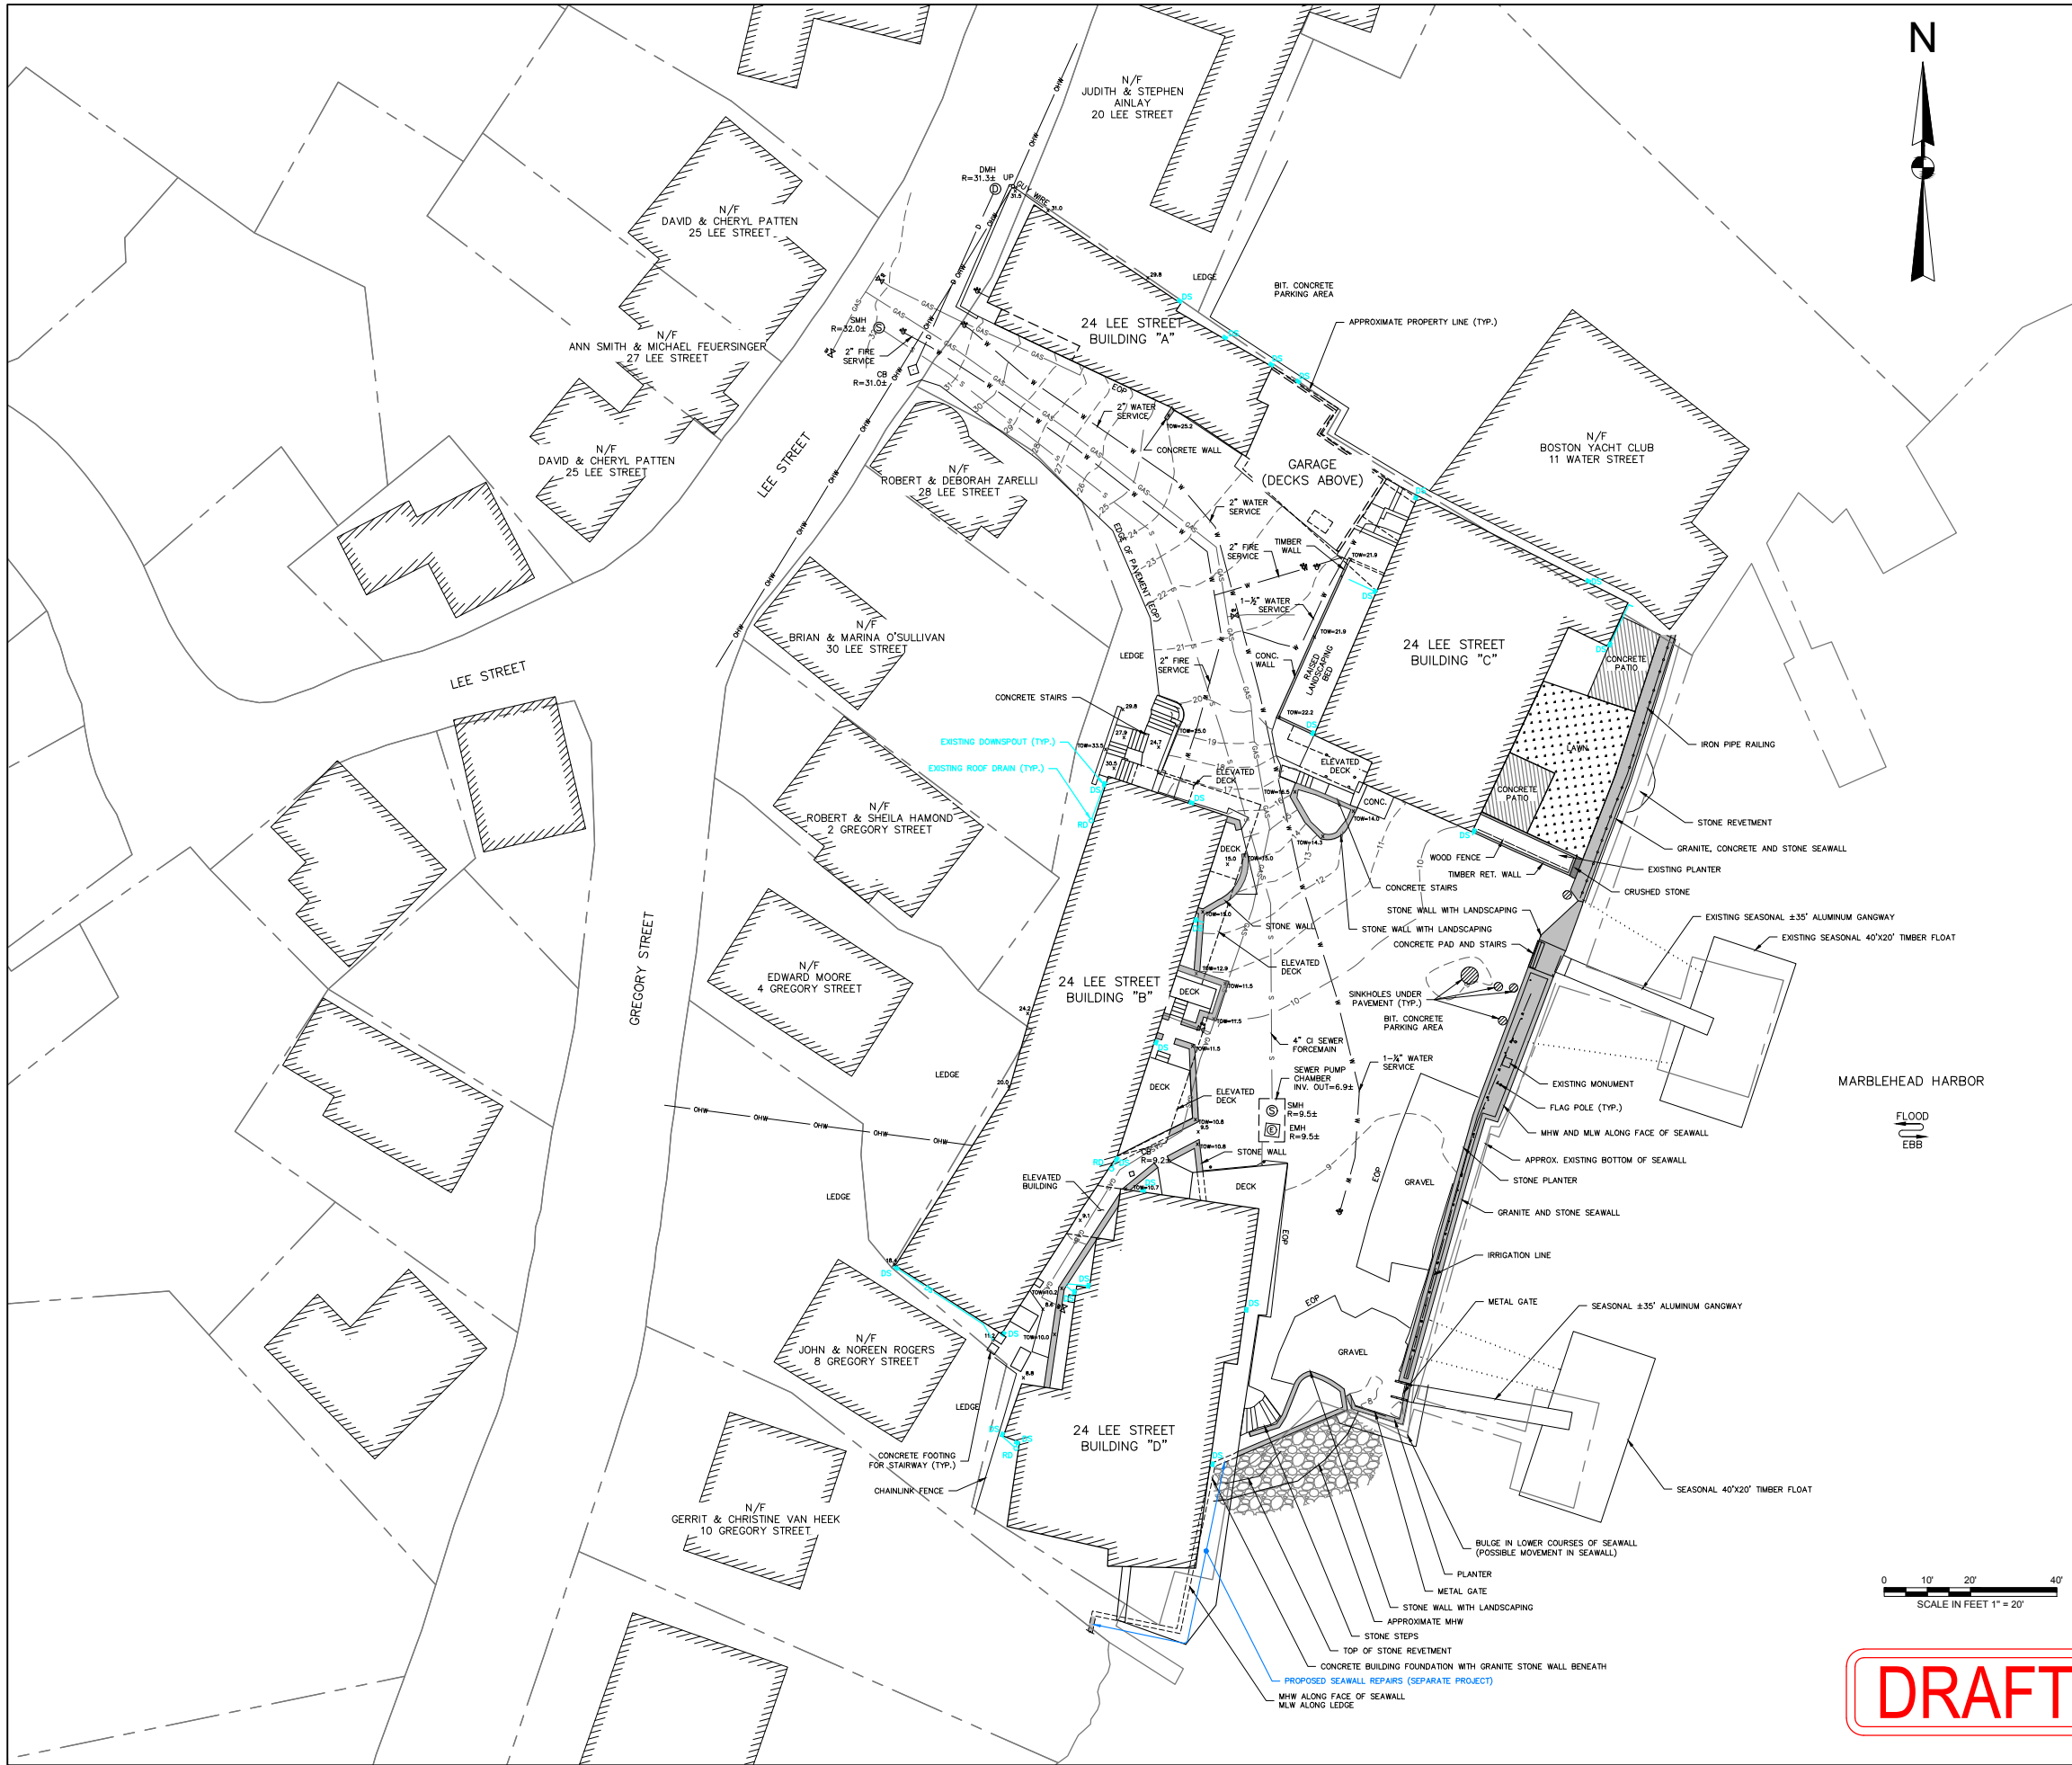
Short-term improvements to Building B, see **Figures 3 & 4 in Appendix C**, would involve addressing the building's down spout discharge locations. Currently, the down spouts from the building discharge to existing grades near the foundation of the existing building or into roof drain pipes near the building foundation. The current location of the down spouts may be contributing to issues with water ponding between Buildings B and D.

Short-term improvements to Building C, see **Figure 3**, would involve addressing the building down spout discharge locations. Currently, the down spouts from the building discharge to existing grades near the foundation of the existing building. In addition, the down spouts near the northeast and northwest corners of building discharge to a small area that separates the building with the existing structure on the property to the north. Also, the down spouts on the western side of the building discharge directly into a raised planting bed, which may be contributing to reported groundwater infiltration in the building.

The down spouts in the northeast corner and at the eastern midpoint of the building could be extended by adding additional lengths of above grade downspout extension to discharge further away from the building foundation. The use of low-profile or retractable down spout extension could be utilized to minimize potential trip hazards. The down spouts in the southeast and southwest corners of the building could be combined and extended by adding additional lengths of above grade downspouts to connect with the existing roof drain pipe near the southwest corner of Building D.

The down spout in the northeast corner of the building could be extended by adding additional lengths of above grade downspout extension to the side of the covered garage wall to discharge further away from the building foundation on the adjacent property. Also, the two down spouts that discharge into the existing raised landscaping bed could be extended with additional lengths of above grade downspout extension beyond the retaining wall, to discharge onto the adjacent paved parking area. In addition, the downspout in the southeast corner of the building could be extended utilizing above grade piping to discharge to the adjacent harbor. Finally, the two existing down spouts in the northeast corner of the building could be combined and extended with additional lengths of above grade downspouts to discharge to the adjacent harbor. The use of low-profile or retractable downspout extension could be utilized to minimize potential trip hazards.
