## **An update from the Board of Trustees regarding October 2023.**

### **Building D project**

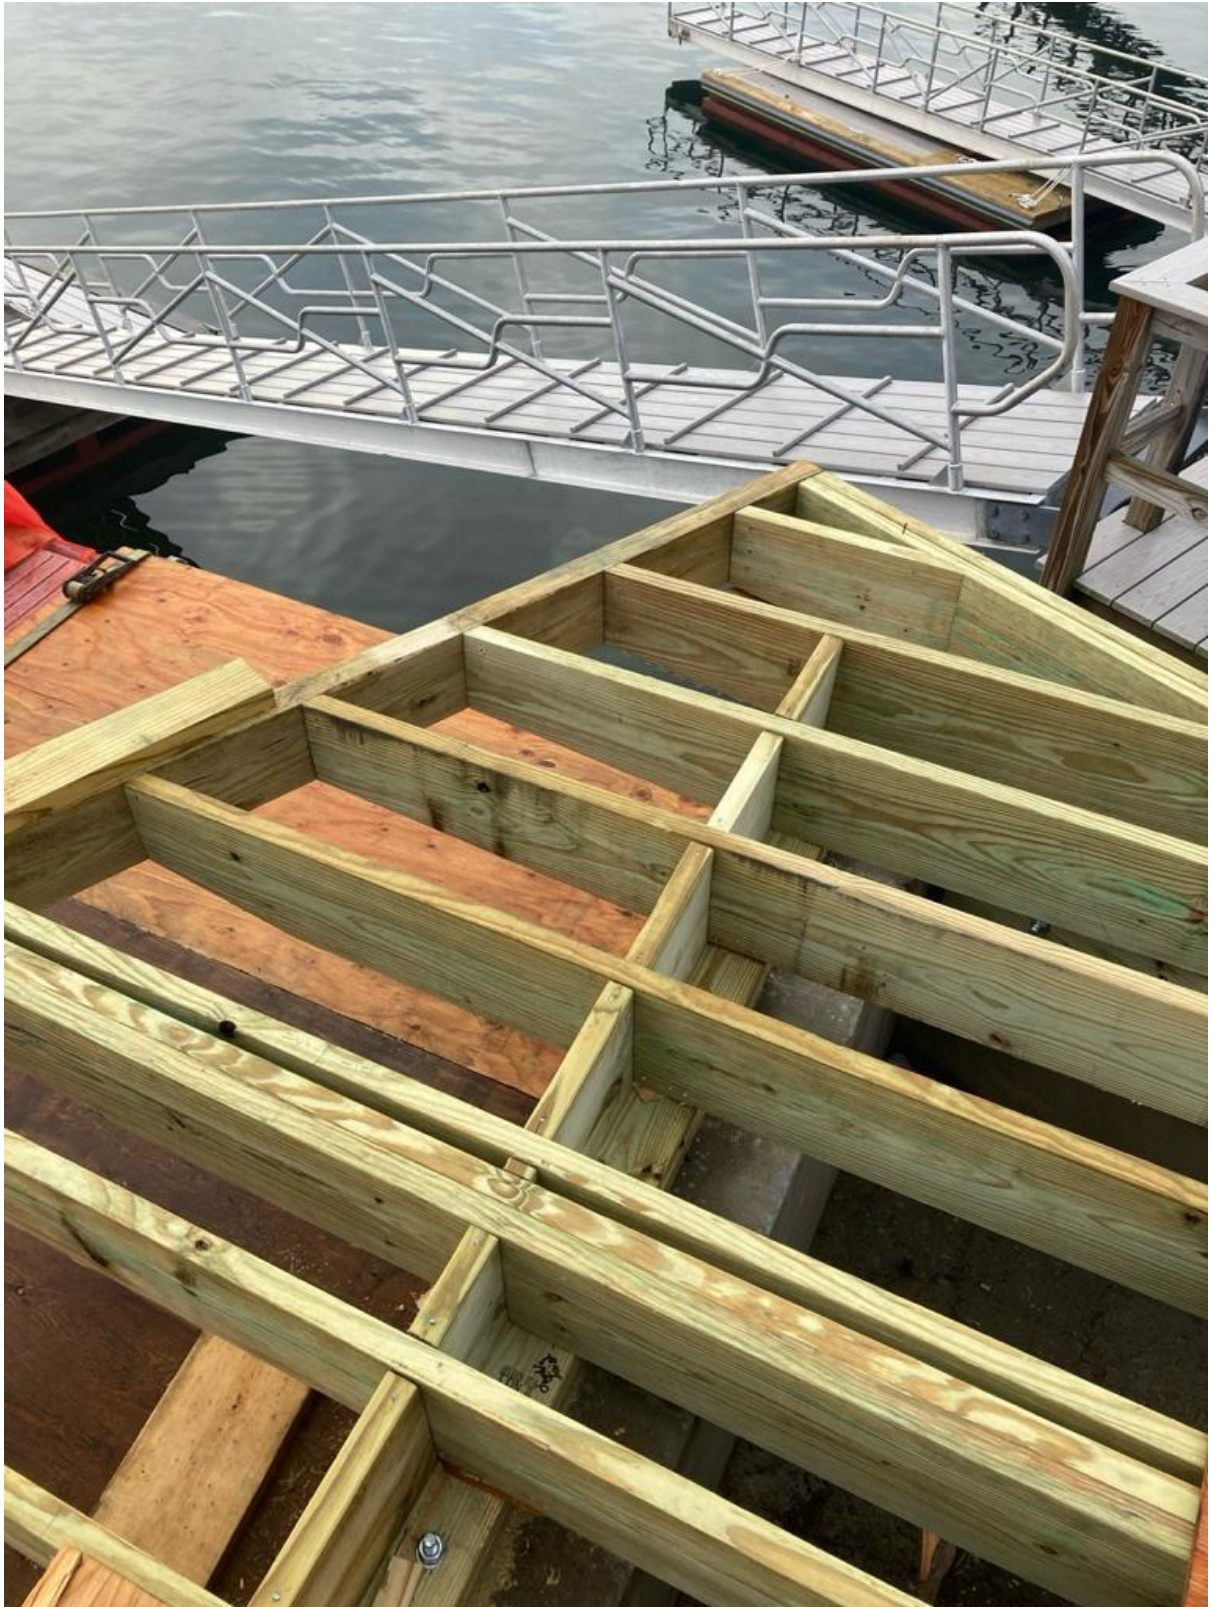
- The project continues to track well. There was continued progress during the month of October. There were, however, several significant problems.
- A large amount of rot of the supporting structure of the first-floor deck was discovered.
- Rotting cantilevered beams that run under the first floor and support the deck structure was also discovered.
- The support structure for the first-floor deck had to be rebuilt which caused a delay of more than six weeks in the project's timeline.
- There was also considerable rot found on the South-East corner of the first and second floor exterior walls that required consultation with the project structural engineer.
- The rot was removed, new internal posts were installed, and the corner was covered with plywood.

*Figure 1 New framing of first floor South East Corner*

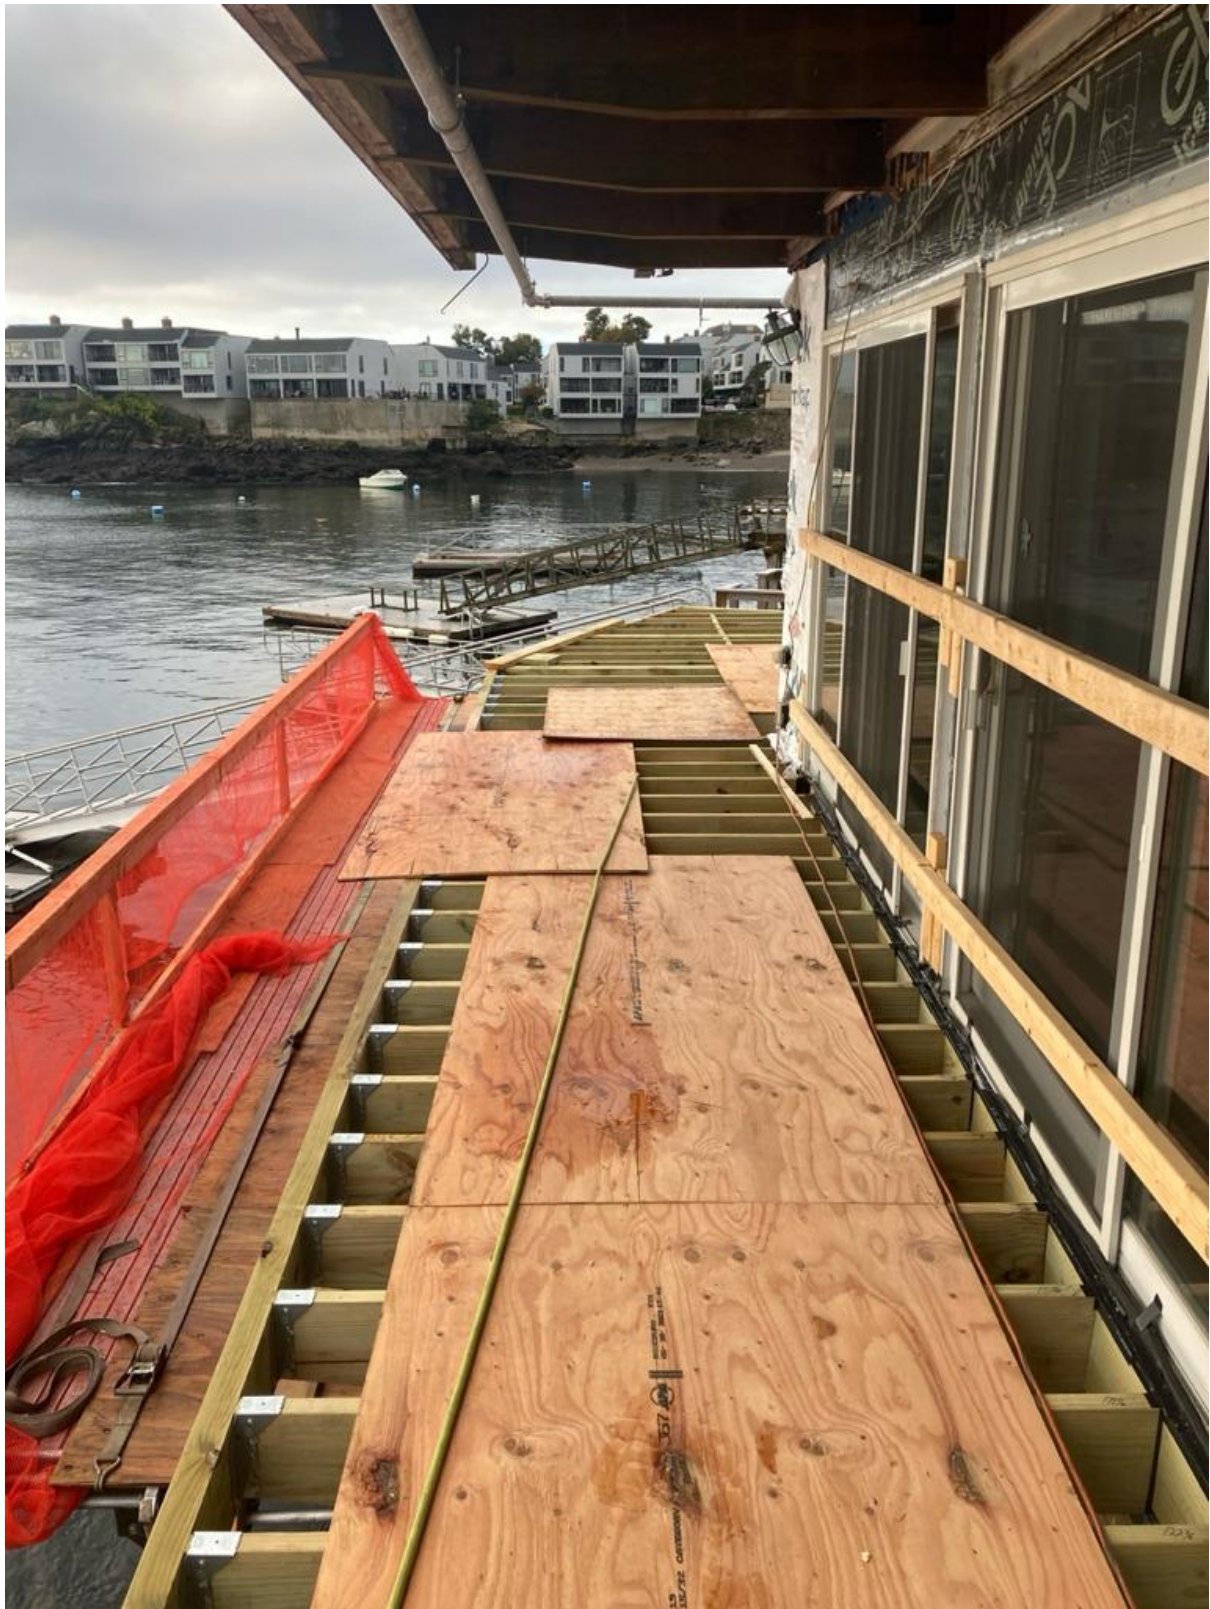
Figure 2 New framing of the 1st floor East Deck

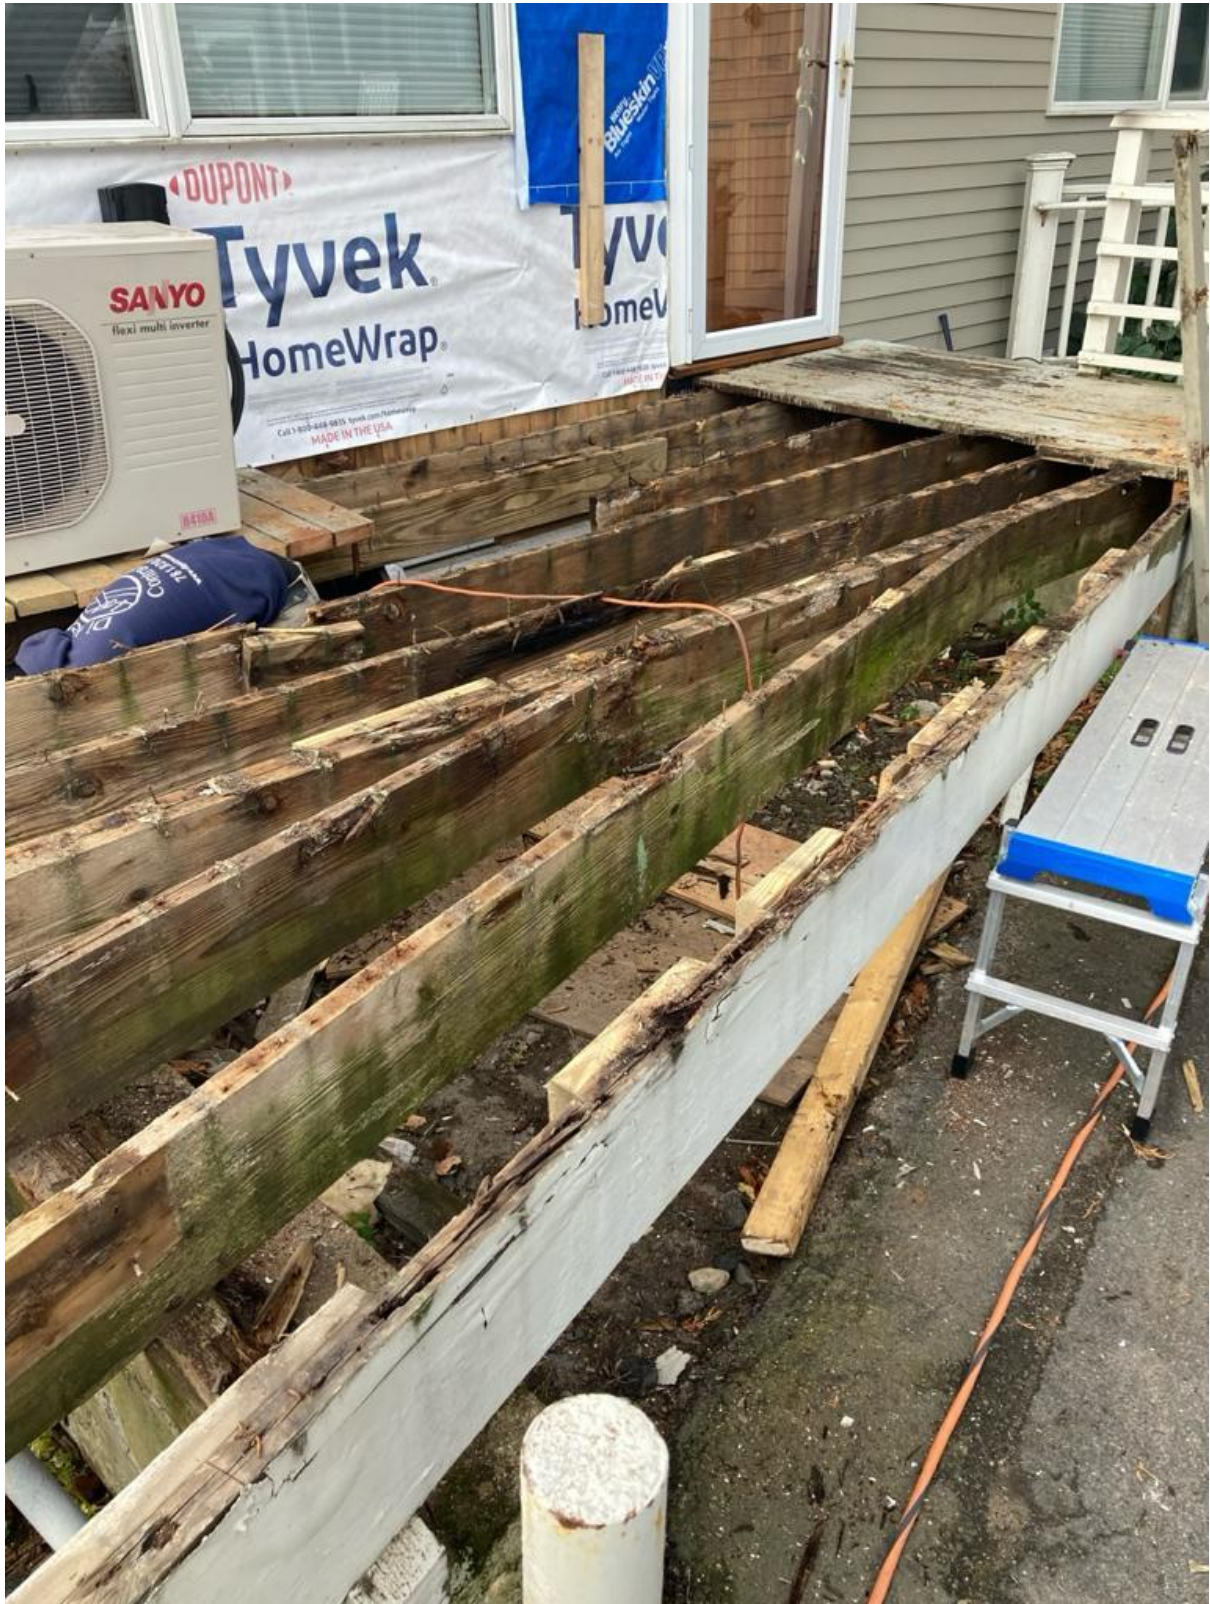
Figure 3 State of the 1st floor North Deck once decking was removed

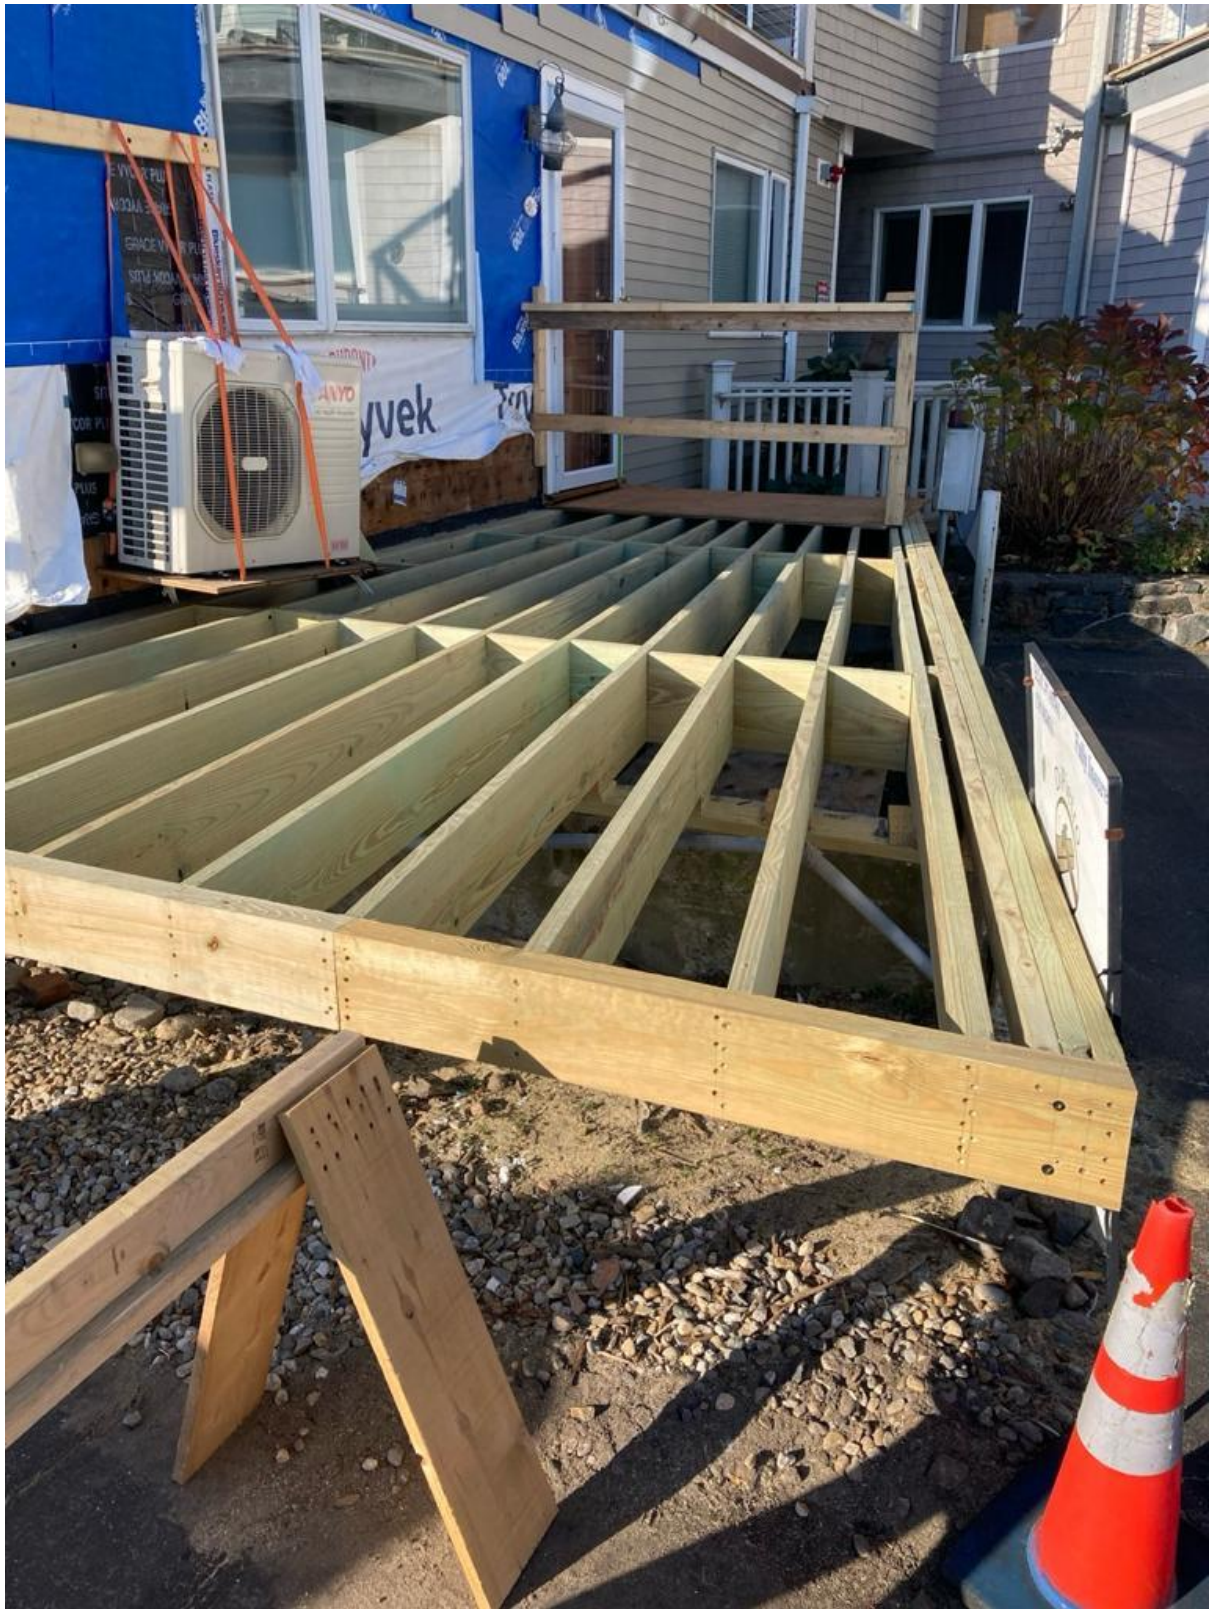
Figure 4 Reframed 1st floor North deck
