## SEAWALL CONDITION ASSESSMENT

LESLEY MANAGEMENT HARBORSIDE CONDOMINIUM  
24 Lee Street  
Marblehead, Massachusetts

February 2017

File No. 18.0172708.00

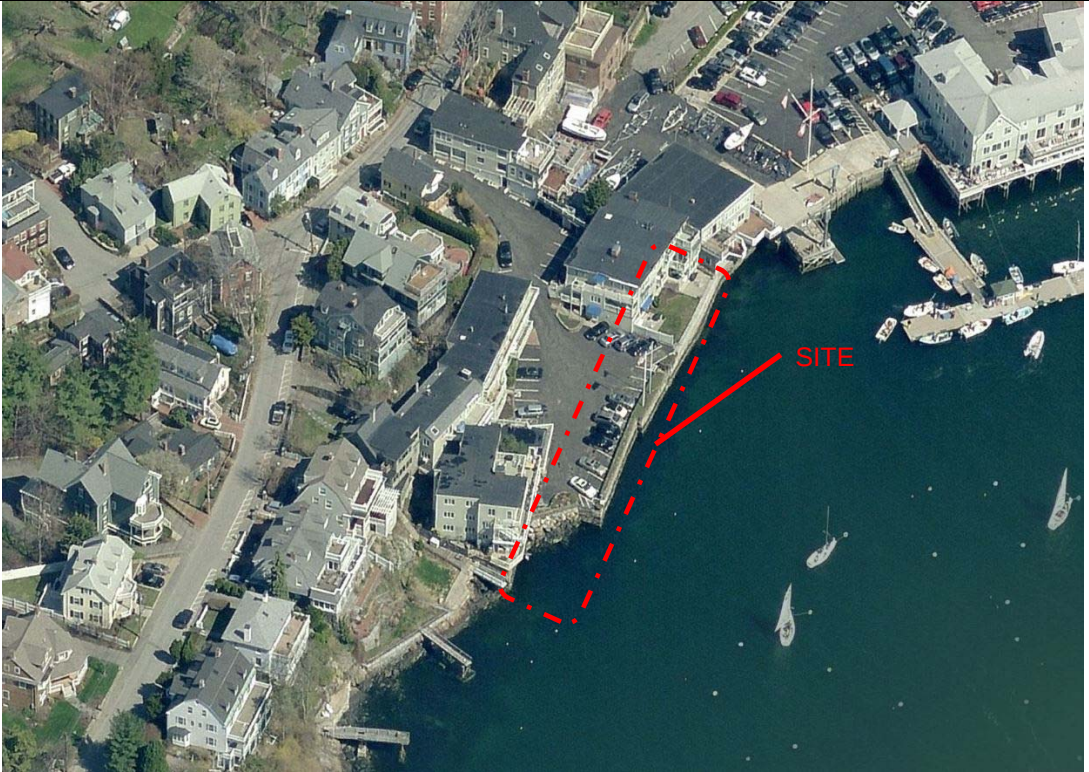
| <b>Photo No.</b><br>1 | <b>Date:</b><br>2016 | | |

| <b>Description:</b><br>Aerial image of the site (Bing Maps). | | | |

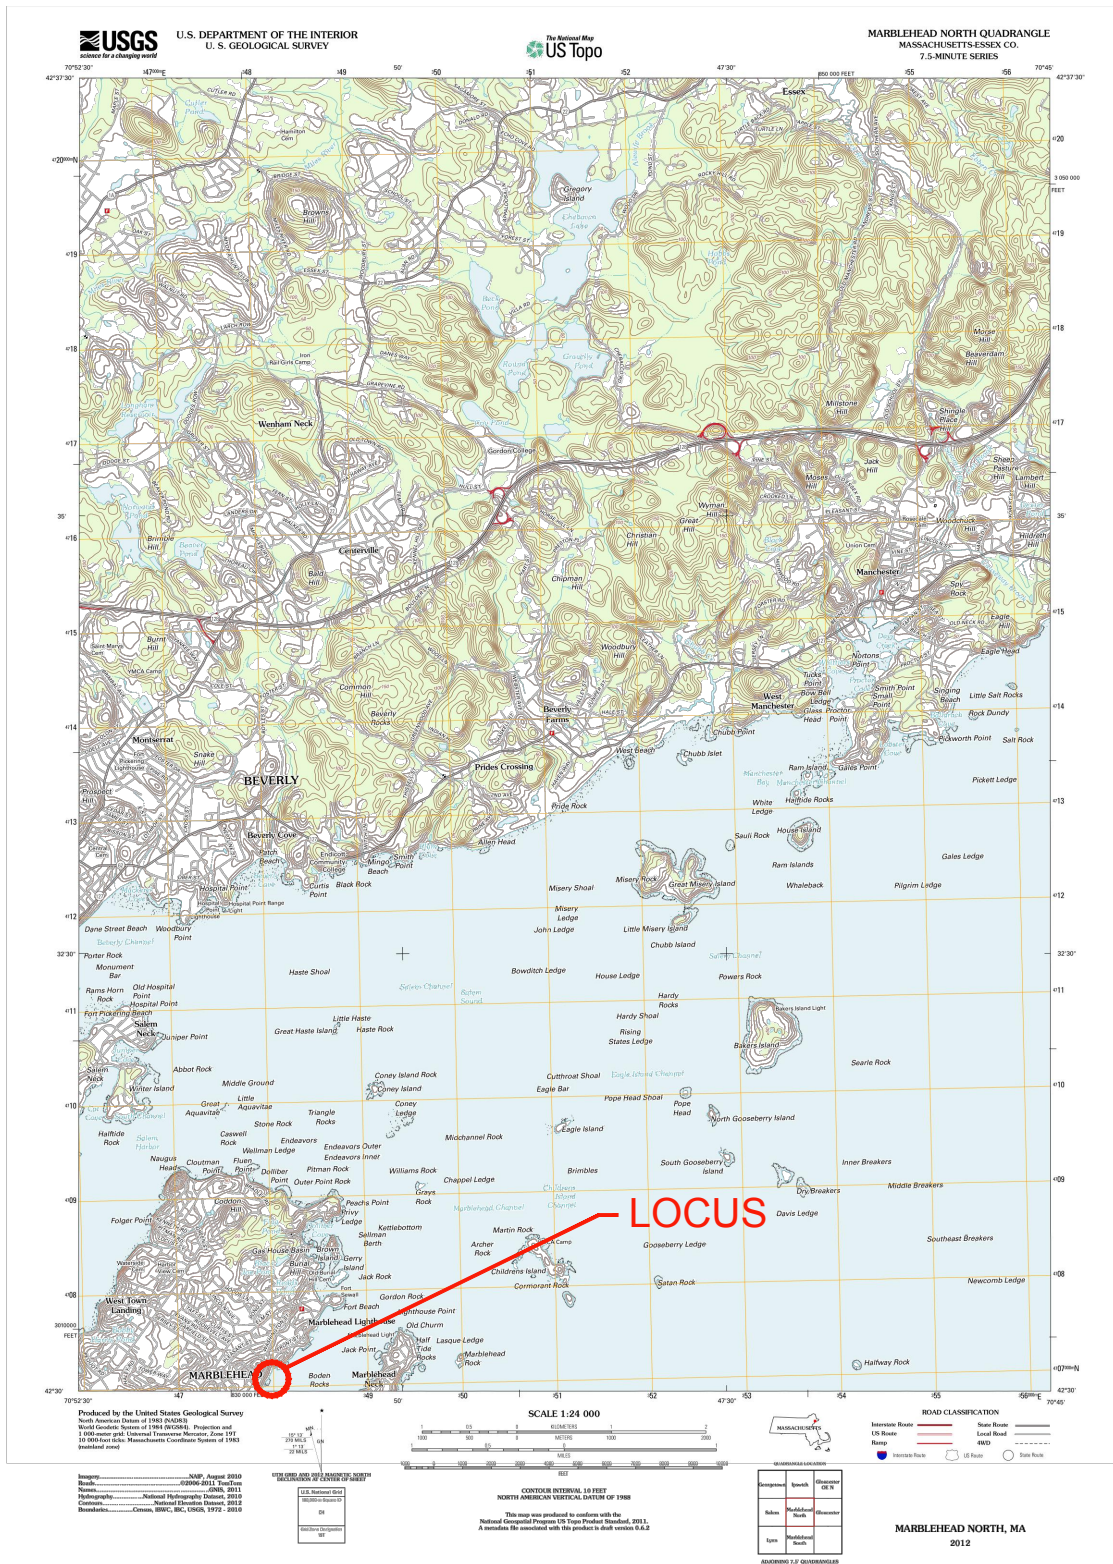
**Appendix C – Figure**  
**Figure 1. Locus Plan**  
**Figure 2. Existing Conditions Plan**

The overall length of the inspected structures fronting Marblehead Harbor is approximately 310 linear feet, and consists of seawalls and stone revetment slope. The seawall portion of the site can be divided into different segments based on height and upper seawall construction type. The seawall length from the northern property limit to southeastern end of the paved parking lot is approximately 205 linear feet. South of the parking lot an approximate 45-foot-long stone riprap slope with a low height masonry seawall above provides protection to the parking lot and the southern condominium building. The remaining portion of the seawall is located beneath the southern condominium building and deck and extends approximately 40 linear feet and then 20 linear feet toward shore to the southern property limit (See Figure 2 in Appendix C for Existing Conditions Plan and general site photographs in Appendix B).
