## **SITE DRAINAGE IMPROVEMENT REPORT**

**LESLEY MANAGEMENT HARBORSIDE CONDOMINIUM**  
24 Lee Street  
Marblehead, Massachusetts

November 2018  
File No. 18.0173596.00

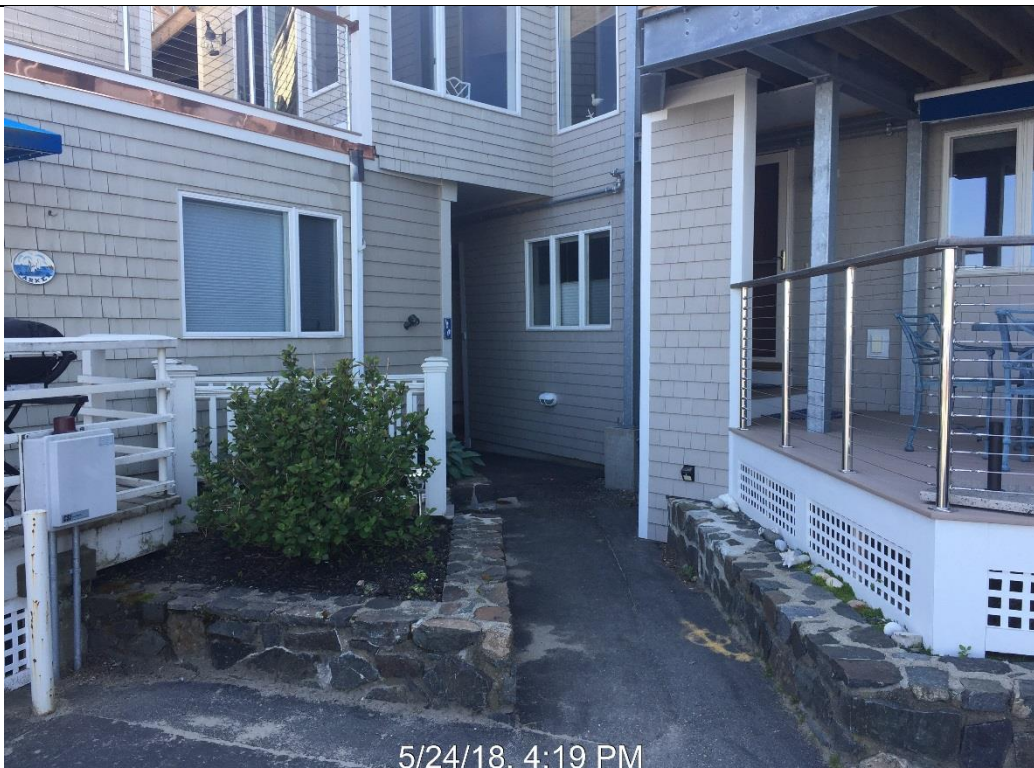
The Building D structure is located in the southern corner of the property, and is approximately 85 feet long, 45 feet wide, with a footprint of approximately 3,350 square feet. The structure has three stories and contains six condominium units see **Photographs 8, 9 & 10**. The structure has exterior decks attached to the building which are either cantilevered or supported by timber posts, and some of the decks have exterior access stairways. Portions of the exterior decks project seaward past the existing granite block seawall that supports the building foundation. A small grassed and landscaped area is located along the southwestern side of the building, and raised landscaping beds are located on the western portion of the building.

| <b>Description:</b><br>View of passage way between Building B and D from the main parking area. | | | |

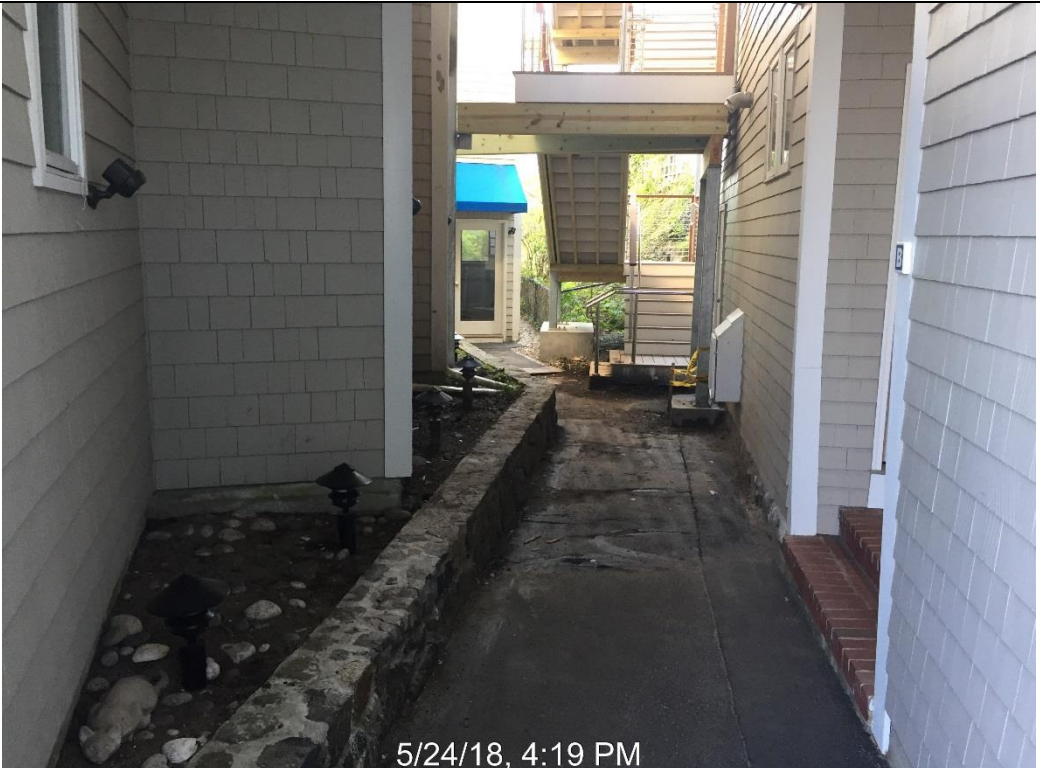
| <b>Description:</b><br>View of passageway between Buildings B and D from inside the passageway. | | | |

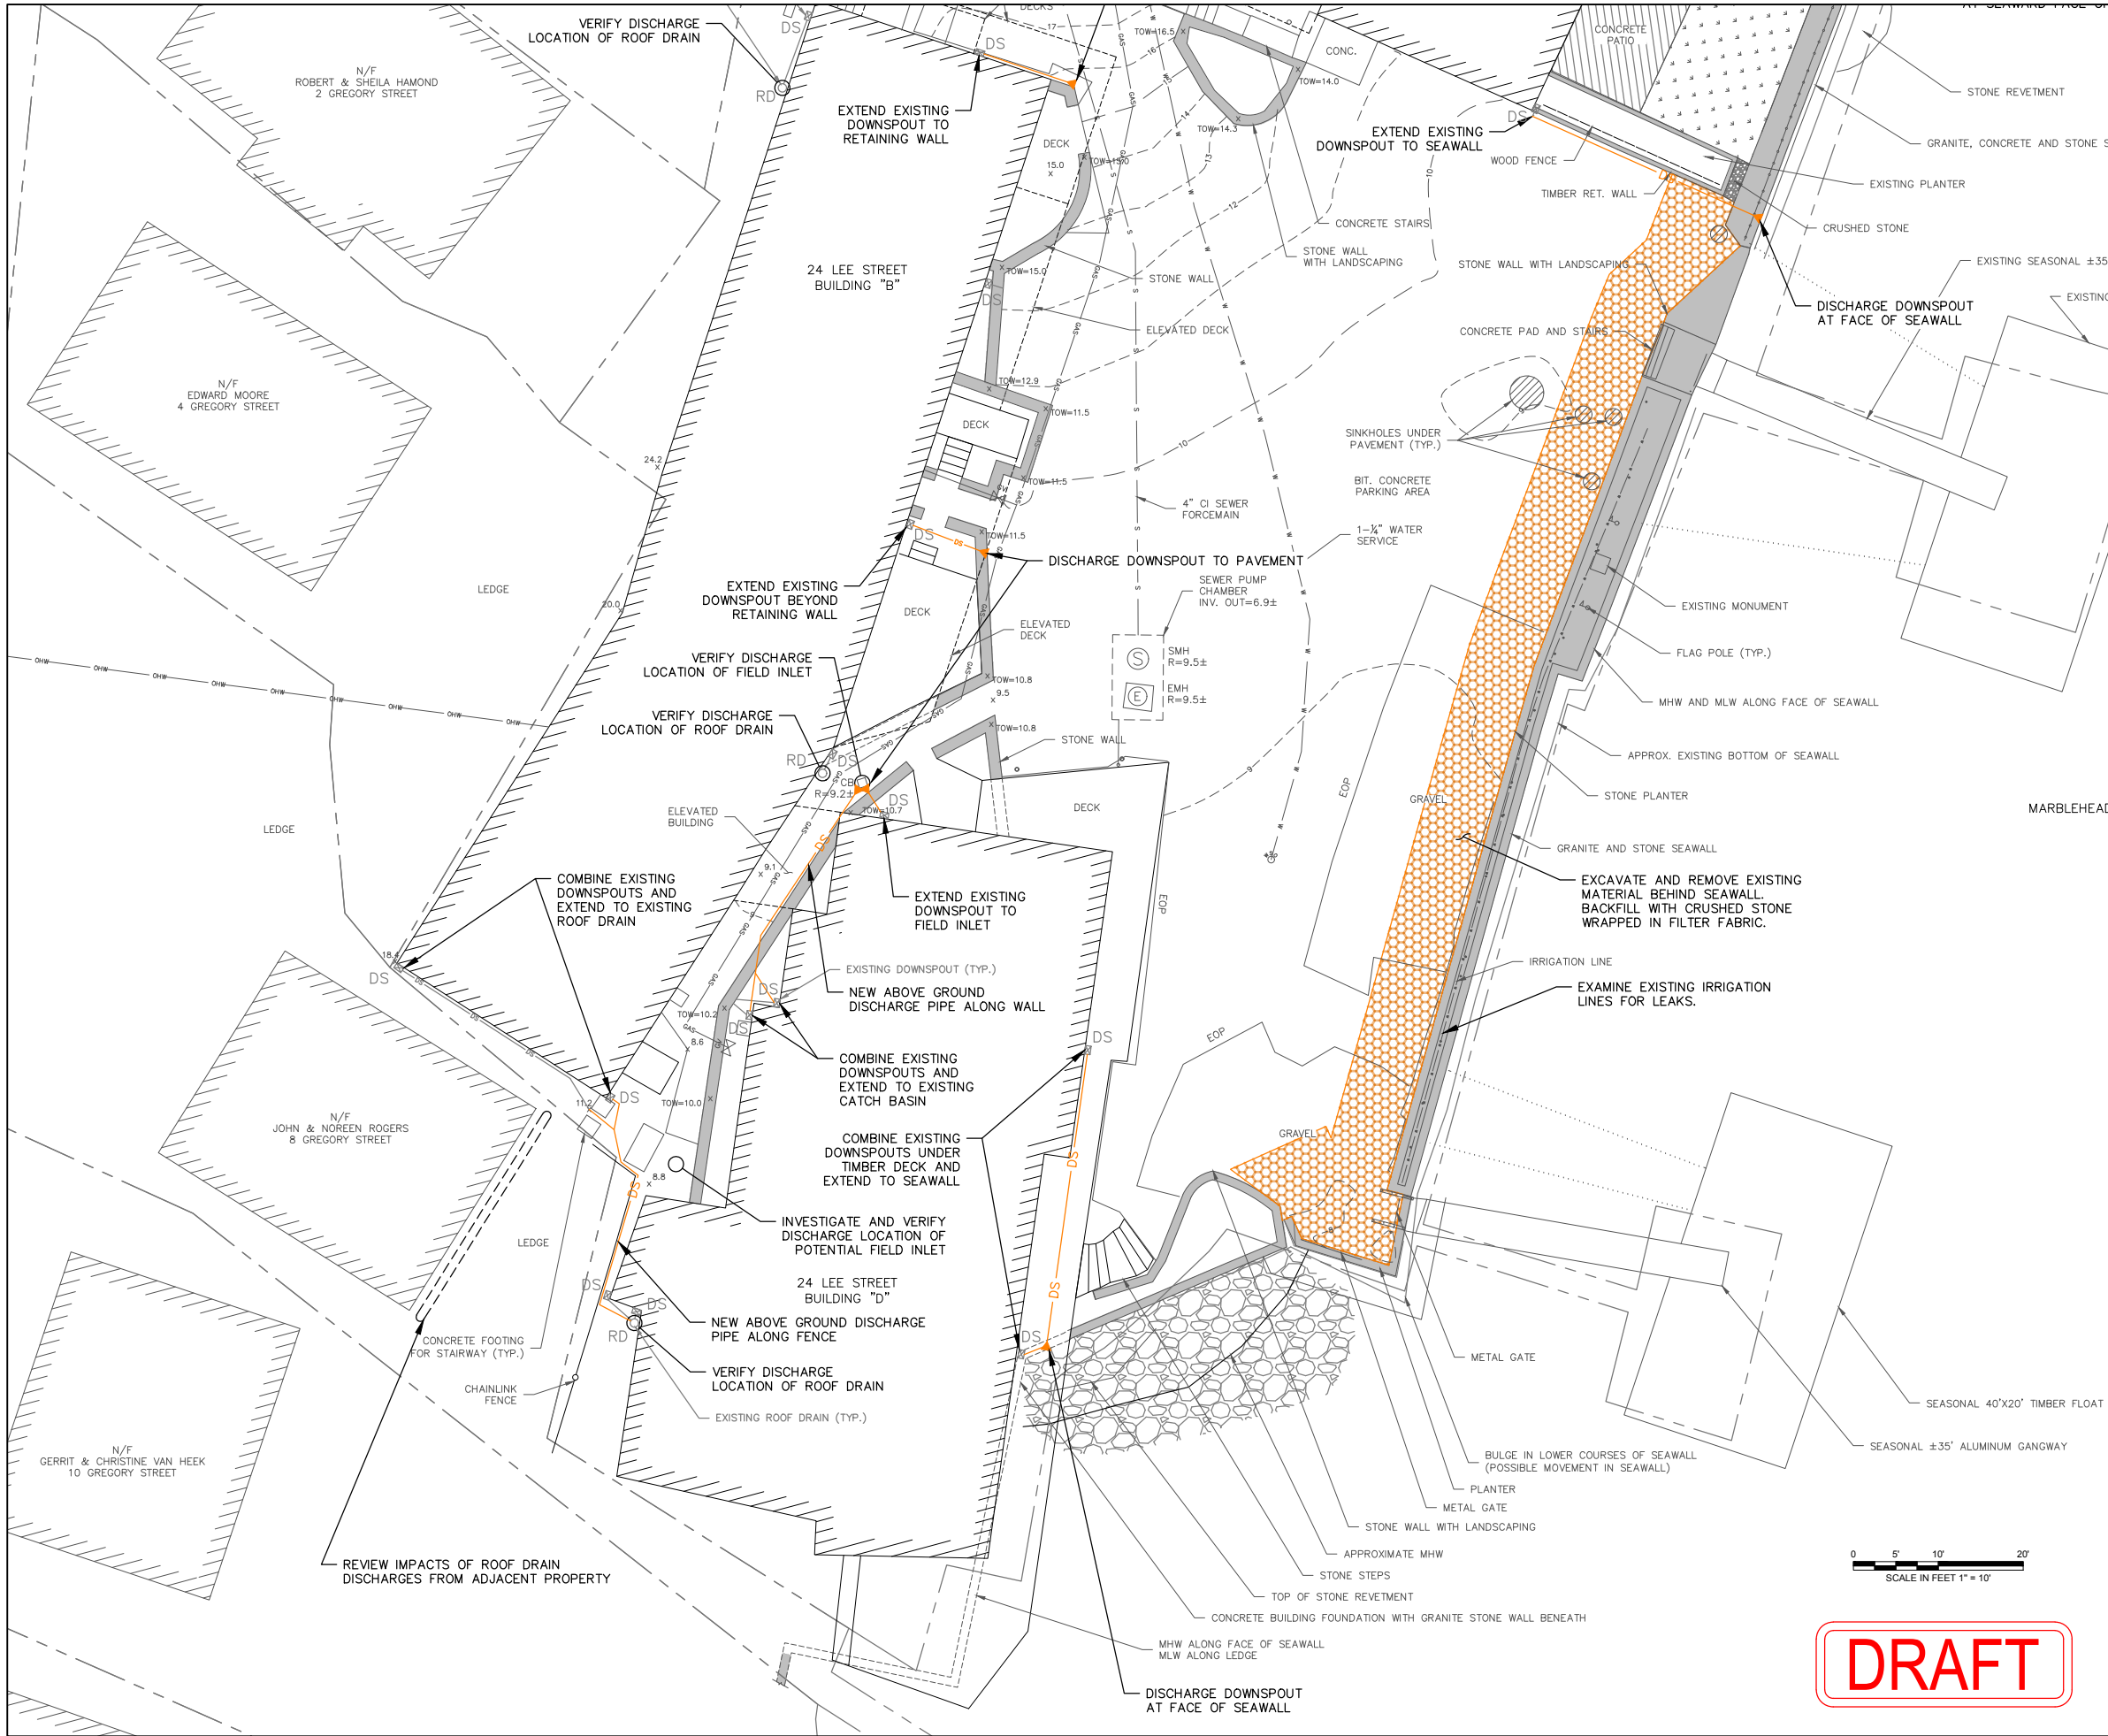
Short-term improvements to Building B, see **Figures 3 & 4 in Appendix C**, would involve addressing the building's down spout discharge locations. Currently, the down spouts from the building discharge to existing grades near the foundation of the existing building or into roof drain pipes near the building foundation. The current location of the down spouts may be contributing to issues with water ponding between Buildings B and D.

Short-term improvements to Building D, see **Figure 4**, would involve addressing the building down spout discharge locations, and the field inlets located in the paved walkway between Building B and D. Currently, the down spouts from the building discharge to existing grades near the foundation of the existing building or into roof drain pipes near the building foundation. Also, the three down spouts near the northwestern corner of the building discharge directly into a raised planting beds that are adjacent to the building foundation. The current outlet locations of the down spouts may be contributing to issues with water ponding between Buildings B and D.

The down spouts in the northeast corner and at the eastern midpoint of the building could be extended by adding additional lengths of above grade downspout extension to discharge further away from the building foundation. The use of low-profile or retractable down spout extension could be utilized to minimize potential trip hazards. The down spouts in the southeast and southwest corners of the building could be combined and extended by adding additional lengths of above grade downspouts to connect with the existing roof drain pipe near the southwest corner of Building D.

The down spouts in the northeast corner of the building could be extended by adding additional lengths of above grade downspout extension to discharge to an existing field inlet located in the paved walkway between Building B and D. The use of low-profile or retractable down spout extension could be utilized to minimize potential trip hazards. In addition, the existing paved walkway near the southeast corner of Building B should be investigated for the presence of an existing field inlet. The field inlets should also be inspected to confirm their final discharge locations prior to directing additional discharges to them.
